# OIL ANALYSIS REPORT

Machine Id  
**MPG A (S/N CAHE-V833200A)**

Component  
**Hydraulic System**

Fluid  
**MOBIL JET OIL II (--- LTR)**

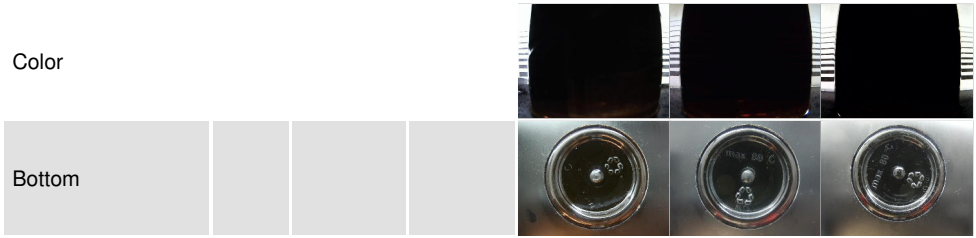
### SAMPLE IMAGES

VISUAL		method	limit/base	current	history1	history2
White Metal	scalar	Visual*	NONE	<b>NONE</b>	NONE	NONE
Yellow Metal	scalar	Visual*	NONE	<b>NONE</b>	NONE	NONE
Precipitate	scalar	Visual*	NONE	<b>NONE</b>	NONE	NONE
Silt	scalar	Visual*	NONE	<b>NONE</b>	NONE	NONE
Debris	scalar	Visual*	NONE	<b>NONE</b>	VLITE	NONE
Sand/Dirt	scalar	Visual*	NONE	<b>NONE</b>	NONE	NONE
Appearance	scalar	Visual*	NORML	<b>NORML</b>	NORML	NORML
Odor	scalar	Visual*	NORML	<b>NORML</b>	NORML	NORML
Emulsified Water	scalar	Visual*	>.1	<b>NEG</b>	NEG	NEG
Free Water	scalar	Visual*		<b>NEG</b>	NEG	NEG

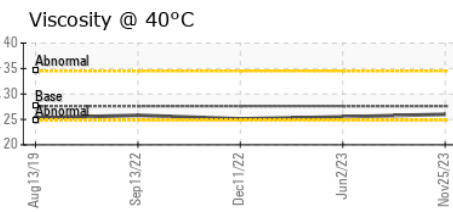
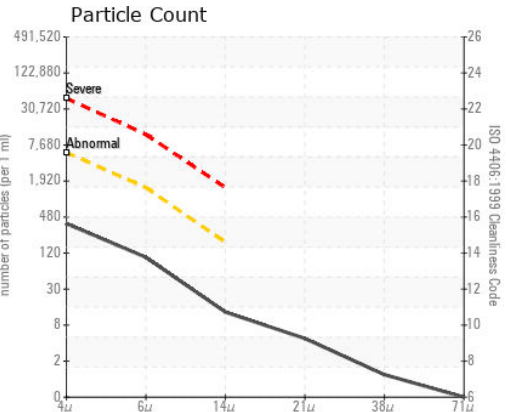
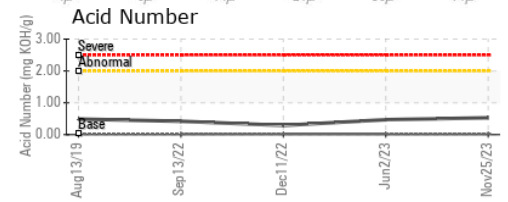
### GRAPHS

FLUID CLEANLINESS		method	limit/base	current	history1	history2
Particles >4µm		ASTM D7647	>5000	<b>328</b>	903	3751
Particles >6µm		ASTM D7647	>1300	<b>90</b>	164	676
Particles >14µm		ASTM D7647	>160	<b>11</b>	13	42
Particles >21µm		ASTM D7647	>40	<b>4</b>	4	15
Particles >38µm		ASTM D7647	>10	<b>1</b>	1	3
Particles >71µm		ASTM D7647	>3	<b>0</b>	1	1
Oil Cleanliness		ISO 4406 (c)	>19/17/14	<b>16/14/11</b>	17/15/11	19/17/13

FLUID DEGRADATION		method	limit/base	current	history1	history2
Acid Number (AN)	mg KOH/g	ASTM D974*	0.03	<b>0.53</b>	0.47	0.29

FLUID PROPERTIES		method	limit/base	current	history1	history2
Visc @ 40°C	cSt	ASTM D7279(m)	27.6	<b>26.0</b>	25.5	25.1

Resample at the next service interval to monitor.  
NOTE: Please provide information regarding reservoir capacity, filter type and micron rating with next sample.
