# OIL ANALYSIS REPORT

Area  
**Gas Compression**  
 Machine Id  
**V653201 GIC**  
 Component  
**Lube System**  
 Fluid  
**MOBIL DTE 832 (--- GAL)**

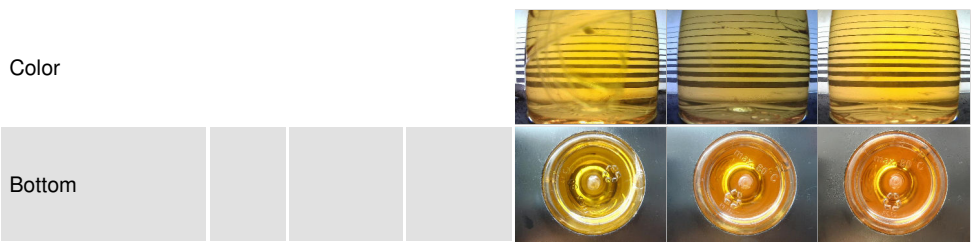
SAMPLE IMAGES		method	limit/base	current	history1	history2
---------------	--	--------	------------	---------	----------	----------

VISUAL		method	limit/base	current	history1	history2
White Metal	scalar	Visual*	NONE	<b>NONE</b>	NONE	NONE
Yellow Metal	scalar	Visual*	NONE	<b>NONE</b>	NONE	NONE
Precipitate	scalar	Visual*	NONE	<b>NONE</b>	NONE	NONE
Silt	scalar	Visual*	NONE	<b>NONE</b>	NONE	NONE
Debris	scalar	Visual*	NONE	<b>NONE</b>	NONE	NONE
Sand/Dirt	scalar	Visual*	NONE	<b>NONE</b>	NONE	NONE
Appearance	scalar	Visual*	NORML	<b>NORML</b>	NORML	NORML
Odor	scalar	Visual*	NORML	<b>NORML</b>	NORML	NORML
Emulsified Water	scalar	Visual*	>0.05	<b>NEG</b>	NEG	NEG
Free Water	scalar	Visual*		<b>NEG</b>	NEG	NEG

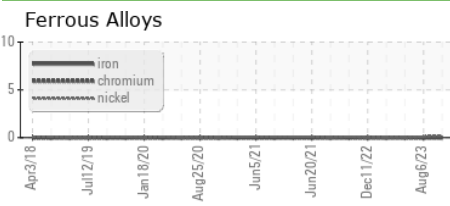
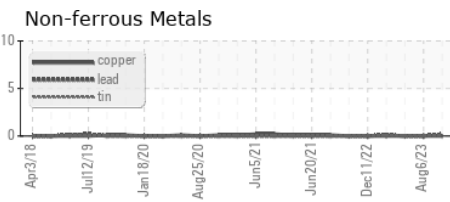
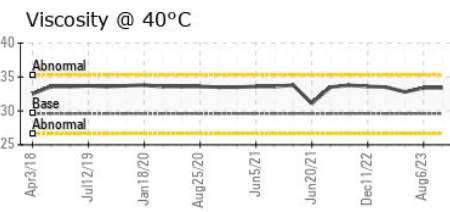
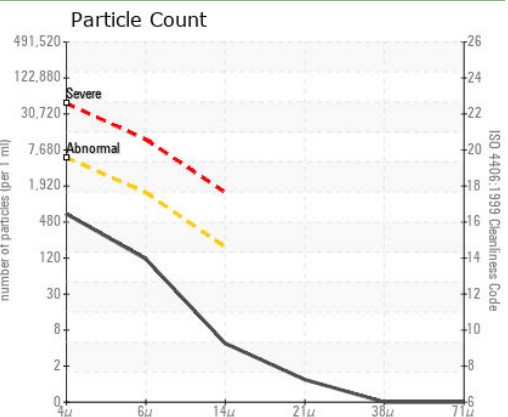
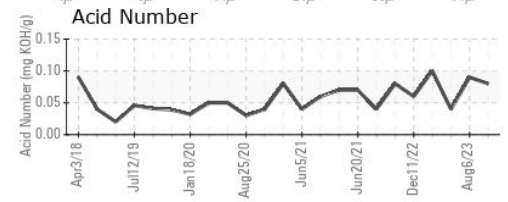
## GRAPHS

All component wear rates are normal.

The system cleanliness is acceptable for your target ISO 4406 cleanliness code. The system and fluid cleanliness is acceptable.

The AN level is acceptable for this fluid. The condition of the oil is suitable for further service.

Resample at the next service interval to monitor.  
 NOTE: Please provide information regarding reservoir capacity, filter type and micron rating with next sample.
