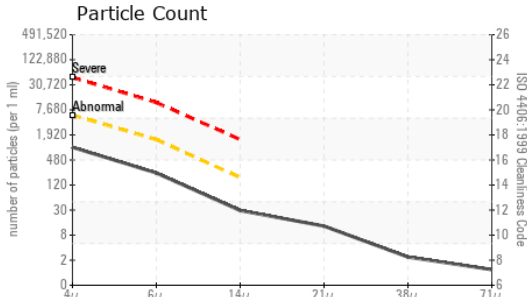
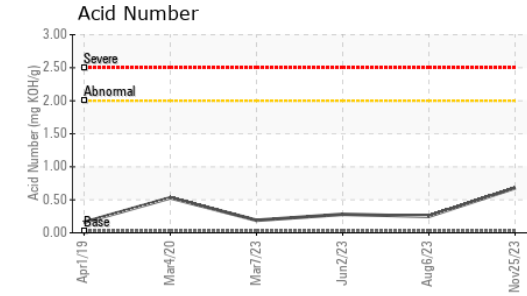
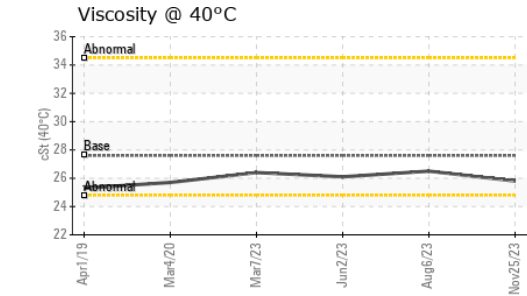
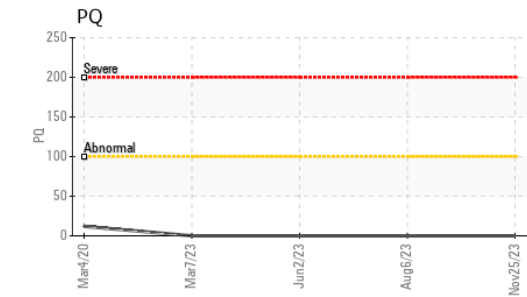
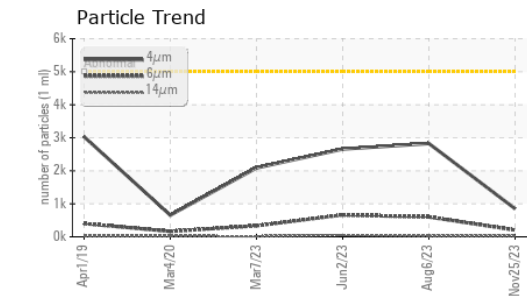
FLUID CLEANLINESS	method	limit/base	current	history1	history2
Particles >4µm	ASTM D7647	>5000	<b>850</b>	2826	2658
Particles >6µm	ASTM D7647	>1300	<b>206</b>	602	662
Particles >14µm	ASTM D7647	>160	<b>26</b>	23	52
Particles >21µm	ASTM D7647	>40	<b>11</b>	4	20
Particles >38µm	ASTM D7647	>10	<b>2</b>	0	2
Particles >71µm	ASTM D7647	>3	<b>1</b>	0	1
Oil Cleanliness	ISO 4406 (c)	>19/17/14	<b>17/15/12</b>	19/16/12	19/17/13

FLUID DEGRADATION	method	limit/base	current	history1	history2
Acid Number (AN)	mg KOH/g ASTM D974*	0.03	<b>0.68</b>	0.25	0.28

FLUID PROPERTIES	method	limit/base	current	history1	history2
Visc @ 40°C	cSt ASTM D7279(m)	27.6	<b>25.8</b>	26.5	26.1

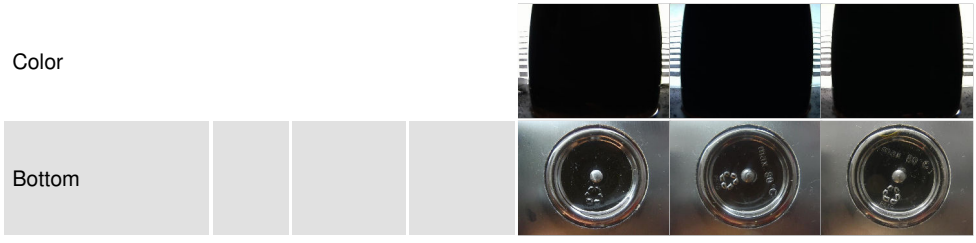
SAMPLE IMAGES	method	limit/base	current	history1	history2
---------------	--------	------------	---------	----------	----------

Color

Bottom
