OIL ANALYSIS REPORT

Machine Id
GTC Train 1 MINERAL OIL (S/N V650201)

Component
1 Gearbox

Fluid
MOBIL DTE 832 (--- LTR)

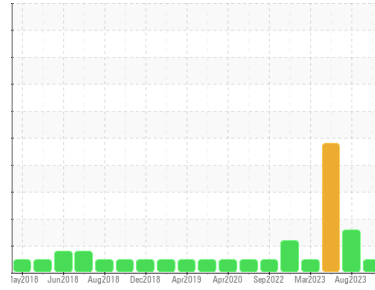
Sample Rating Trend

NORMAL

All component wear rates are normal.

There is no indication of any contamination in the oil.

The AN level is acceptable for this fluid. The condition of the oil is suitable for further service.

Resample at the next service interval to monitor.
NOTE: Please provide information regarding reservoir capacity, filter type and micron rating with next sample.
