OIL ANALYSIS REPORT

Machine Id
EPIROC MT65 TRK219

Component
Rear Left Planetary

Fluid
PENNZOIL SYNTHETIC SAE 75W140 GL-5 (--- GAL)

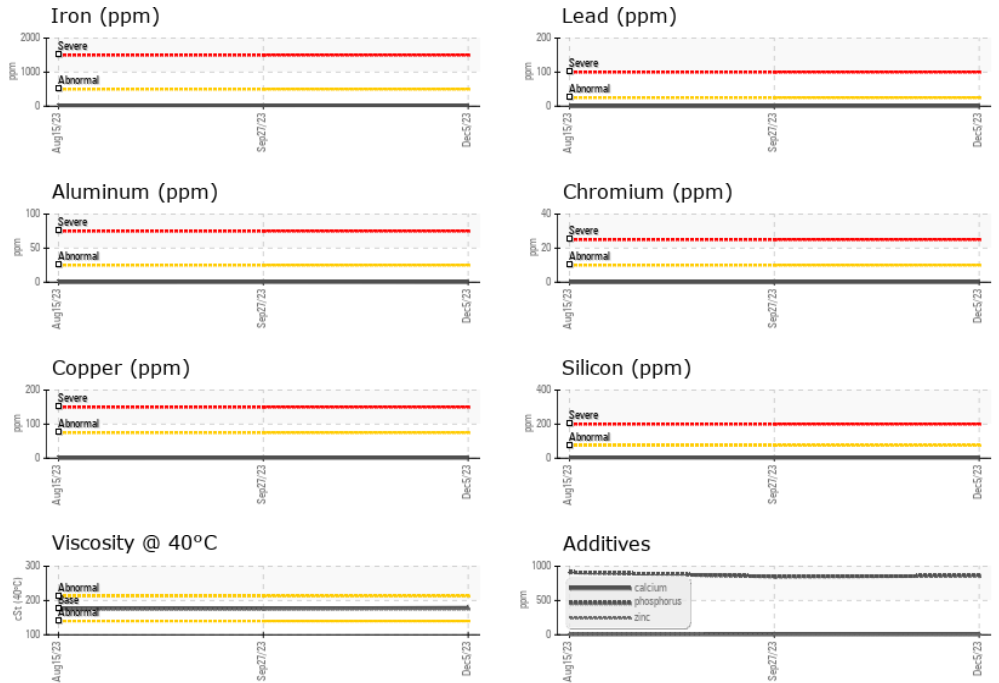
GRAPHS

All component wear rates are normal.

There is no indication of any contamination in the oil.

The condition of the oil is acceptable for the time in service.

Resample at the next service interval to monitor.
