OIL ANALYSIS REPORT

Machine Id
EPIROC MT65 TRK219

Component
Front Right Planetary

Fluid
PENNZOIL SYNTHETIC SAE 75W140 GL-5 (--- GAL)

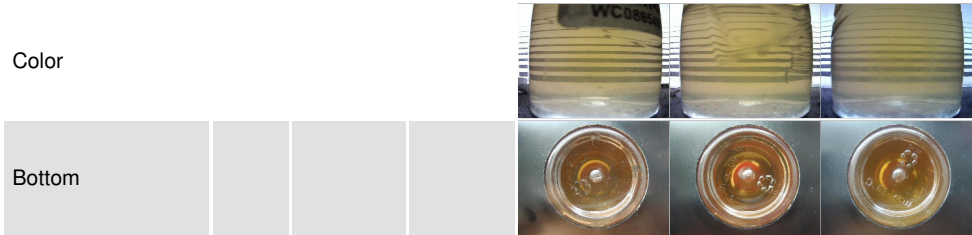
SAMPLE IMAGES	method	limit/base	current	history1	history2
---------------	--------	------------	---------	----------	----------

VISUAL	method	limit/base	current	history1	history2
White Metal	scalar	Visual*	NONE	NONE	NONE
Yellow Metal	scalar	Visual*	NONE	NONE	NONE
Precipitate	scalar	Visual*	NONE	NONE	NONE
Silt	scalar	Visual*	NONE	NONE	NONE
Debris	scalar	Visual*	NONE	NONE	VLITE
Sand/Dirt	scalar	Visual*	NONE	NONE	NONE
Appearance	scalar	Visual*	NORML	NORML	NORML
Odor	scalar	Visual*	NORML	NORML	NORML
Emulsified Water	scalar	Visual*	>0.2	NEG	NEG
Free Water	scalar	Visual*		NEG	NEG

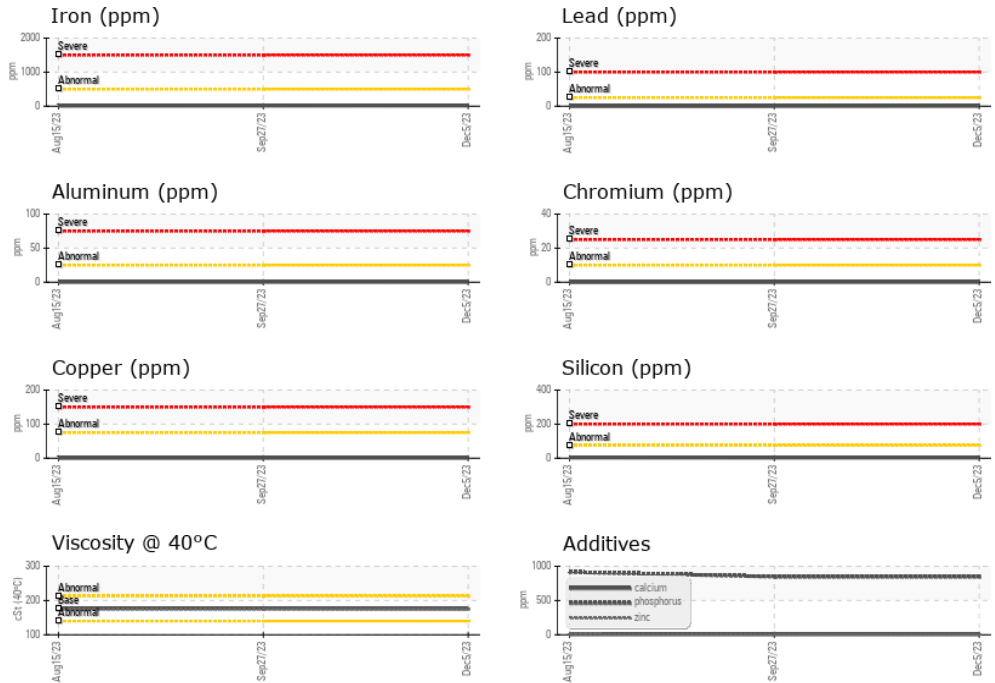
GRAPHS

All component wear rates are normal.

There is no indication of any contamination in the oil.

The condition of the oil is acceptable for the time in service.

Resample at the next service interval to monitor.
