# OIL ANALYSIS REPORT

Area  
**(C-GKWE)**  
 Machine Id  
**DEHAVILLAND PCE-FA1209 (S/N 440)**  
 Component  
**Left Jet Turbine**  
 Fluid  
**MOBIL JET OIL II (--- GAL)**

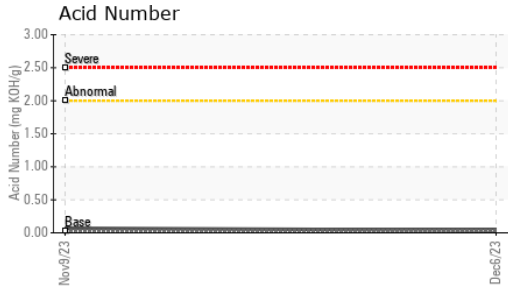
## GRAPHS

FLUID DEGRADATION		method	limit/base	current	history1	history2
Acid Number (AN)	mg KOH/g	ASTM D974*	0.03	<b>0.04</b>	0.07	---
