OIL ANALYSIS REPORT

Area
IRON SHORING
 Machine Id
100-037
 Component
Left Final Drive
 Fluid
NOT GIVEN (--- GAL)

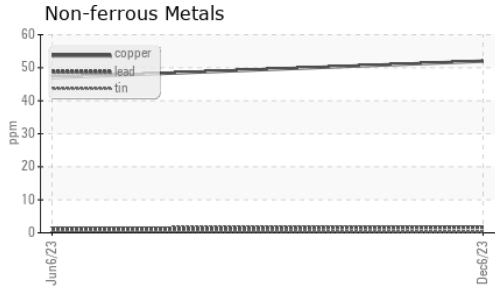
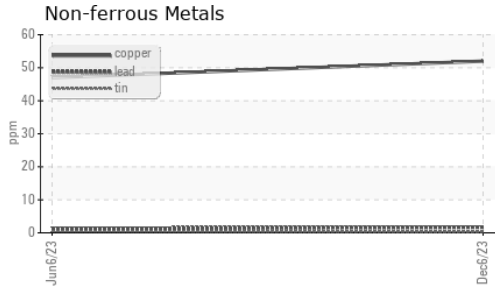
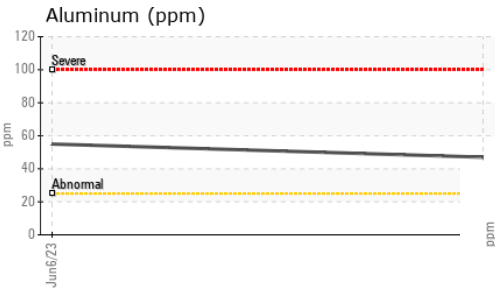
GRAPHS

All component wear rates are normal.

There is no indication of any contamination in the oil.

The condition of the oil is acceptable for the time in service.

Resample at the next service interval to monitor.
