GREASE ANALYSIS

Area
EAST CRANE
 Machine Id
170831 GREASE 270 WEST
 Component
Grease
 Fluid
IRVING LUBEX SYN 2 46 (--- GAL)

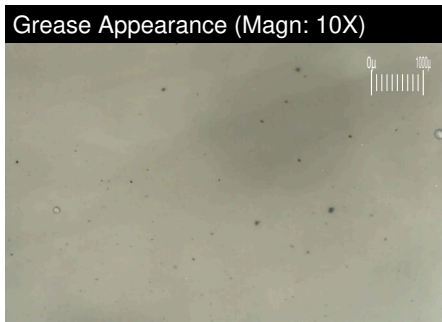
GRAPHS

All component wear rates are normal.

The condition of the grease is acceptable for the time in service.

There is no indication of any contamination in the grease.
