# OIL ANALYSIS REPORT

Area  
**(C-FKEX)**  
 Machine Id  
**[C-FKEX] BEECHCRAFT KING AIR B200 PCE-PJ0150**  
 Component  
**Left Jet Turbine**  
 Fluid  
**BP TURBO OIL 2380 (--- GAL)**

# FERROGRAPHY REPORT

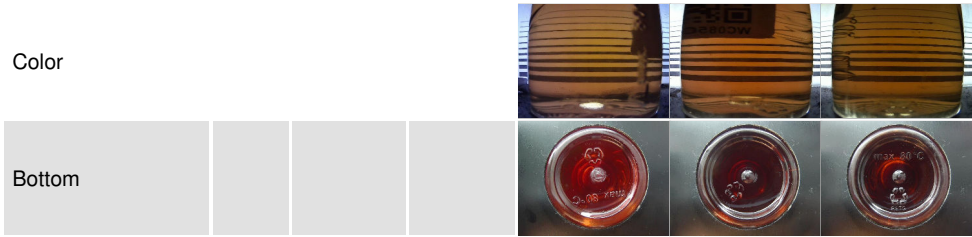
### SAMPLE IMAGES

The water content is negligible. There is no indication of any contamination in the oil.

Resample at the next service interval to monitor.  
 NOTE: Please provide information regarding reservoir capacity, filter type and micron rating with next sample.

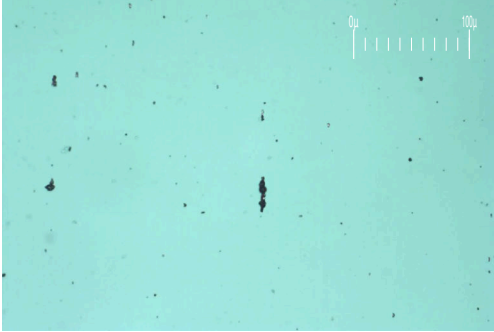
Magn: 200x Illum: BC

All component wear rates are normal. The ferroggraphy results are normal indicating no abnormal wear in the system.
