OIL ANALYSIS REPORT

Machine Id
sludge pump agitator 3 gear box (S/N 012-79170-AGM3)

Gearbox

ESSO SPARTAN EP 68 (--- GAL)

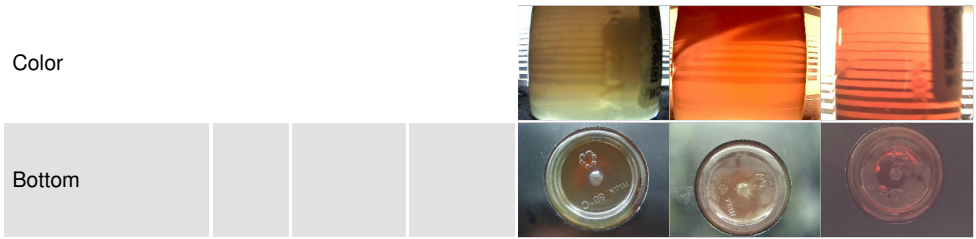
| SAMPLE IMAGES | method | limit/base | current | history1 | history2 |

| VISUAL | method | limit/base | current | history1 | history2 |
|---|---|---|---|---|---|
| Appearance | scalar | Visual* | NORML | NORML | NORML |

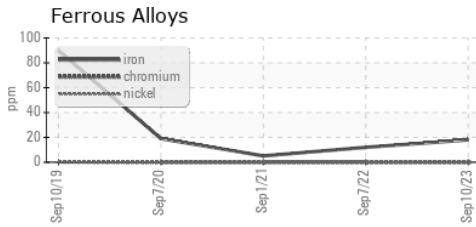
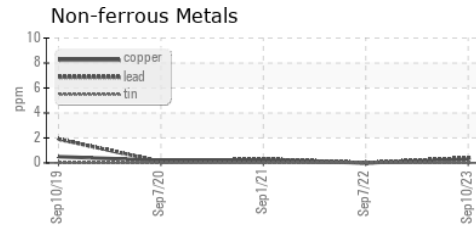
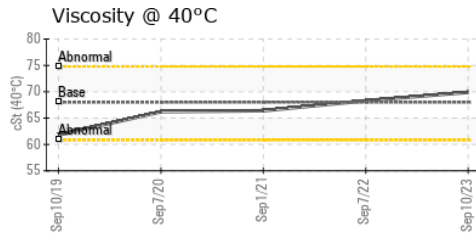
GRAPHS

All component wear rates are normal.

The condition of the oil is acceptable for the time in service.

Resample at the next service interval to monitor.
NOTE: Please provide information regarding reservoir capacity, filter type and micron rating with next sample.
