# 0-37100-BELV-001 BUCKET CONVEYOR 1

Crusher

GEAR OIL ISO 150 (--- GAL)

# **OIL ANALYSIS REPORT**

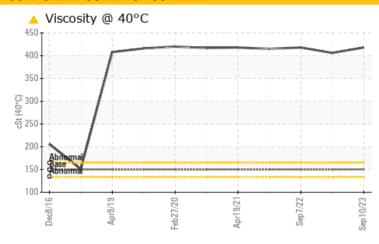
# **COMPONENT CONDITION SUMMARY**

Sample Status				ABNORMAL	ABNORMAL	ABNORMAL
Visc @ 40°C	cSt	ASTM D7279(m)	150	<b>418</b>	<b>4</b> 06	<u>418</u>

Viscosity of sample indicates oil is within ISO 460 range, advise investigate. The condition of the oil is acceptable for the time in service.

Little or no information is provided as to the component and lubricant being tested. Recommendations are therefore generic in nature and may not apply to the current application. Please forward information as to equipment type, reservoir capacity, lubricant type and any pertinent information to allow for a more accurate assessment. Resample at the next service interval to monitor. NOTE: Please provide information regarding reservoir capacity, filter type and micron rating with next sample. Please specify the brand, type, and viscosity of the oil on your next sample.
