ROTARY AIR LOCK SILO #2 GEARBOX

Customer Id: ONTATI Sample No.: WC0822020 Lab Number: 02604240 Test Package: IND 1

OIL ANALYSIS REPORT

Ontario Power Generation ATIKOKAN T.G.S., BOX 1900 ATIKOKAN, ON

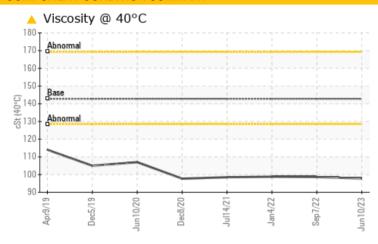
COMPONENT CONDITION SUMMARY

PROBLEMATIC T	EST RE	SULTS				
Sample Status				ABNORMAL	ABNORMAL	ABNORMAL
Visc @ 40°C	cSt	ASTM D7279(m)	142.8	97.8	△ 98.6	△ 98.8

Viscosity of sample indicates oil is within ISO 100 range, advise investigate. The condition of the oil is acceptable for the time in service.

Resample at the next service interval to monitor. NOTE: Please provide information regarding reservoir capacity, filter type and micron rating with next sample.

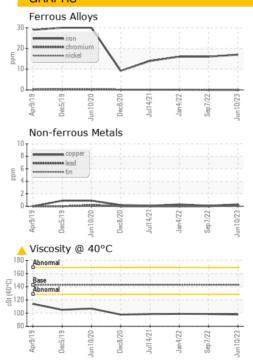
GRAPHS

VISUAL		method	limit/base	current	history1	history2
White Metal	scalar	Visual*	NONE	NONE	NONE	NONE
Yellow Metal	scalar	Visual*	NONE	NONE	NONE	NONE
Precipitate	scalar	Visual*	NONE	NONE	NONE	NONE
Silt	scalar	Visual*	NONE	NONE	NONE	NONE
Debris	scalar	Visual*	NONE	NONE	NONE	NONE
Sand/Dirt	scalar	Visual*	NONE	NONE	NONE	NONE
Appearance	scalar	Visual*	NORML	NORML	NORML	NORML
Odor	scalar	Visual*	NORML	NORML	NORML	NORML
Emulsified Water	scalar	Visual*	>0.2	NEG	NEG	NEG
Free Water	scalar	Visual*		NEG	NEG	NEG
FLUID PROPERT	TES	method	limit/base	current	history1	history2
Visc @ 40°C	cSt	ASTM D7279(m)	142.8	△ 97.8	▲ 98.6	▲ 98.8
SAMPLE IMAGES	3	method	limit/base	current	history1	history2
Color
