OIL ANALYSIS REPORT

Machine Id
SILO 2 DISCHARGE SCREW CONVEYOR 9 GEARBOX (S/N 0-37200-S009)

Component
Gearbox

Fluid
ESSO SPARTAN EP 460 (17 LTR)

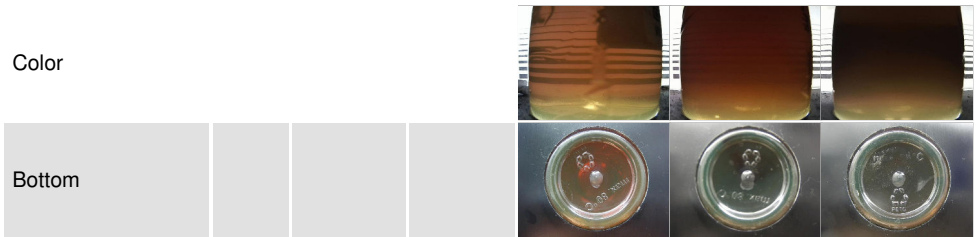
SAMPLE IMAGES	method	limit/base	current	history1	history2
---------------	--------	------------	---------	----------	----------

VISUAL	method	limit/base	current	history1	history2
White Metal	scalar	Visual*	NONE	NONE	NONE
Yellow Metal	scalar	Visual*	NONE	NONE	NONE
Precipitate	scalar	Visual*	NONE	NONE	NONE
Silt	scalar	Visual*	NONE	NONE	NONE
Debris	scalar	Visual*	NONE	NONE	NONE
Sand/Dirt	scalar	Visual*	NONE	NONE	NONE
Appearance	scalar	Visual*	NORML	NORML	NORML
Odor	scalar	Visual*	NORML	NORML	NORML
Emulsified Water	scalar	Visual*	>0.2	NEG	NEG
Free Water	scalar	Visual*		NEG	NEG

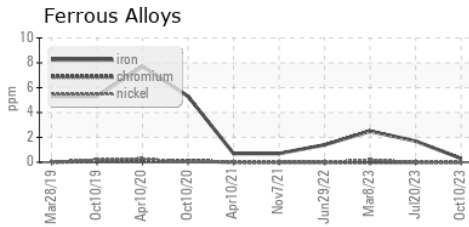
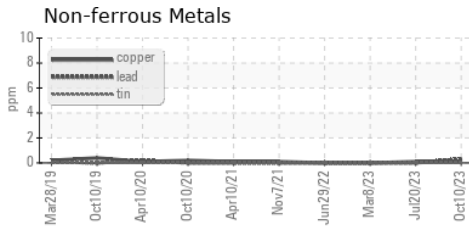
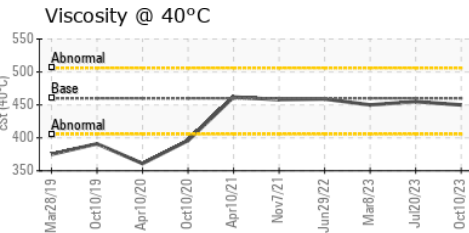
GRAPHS

All component wear rates are normal.

There is no indication of any contamination in the oil.

The condition of the oil is acceptable for the time in service.

Resample at the next service interval to monitor.
