# OIL ANALYSIS REPORT

## Machine Id **A10 - Generator (Upper) Guide Bearing**

Component  
**Generator Bearing**

Fluid  
**PETRO CANADA TURBOFLO R&O 46 (960 LTR)**

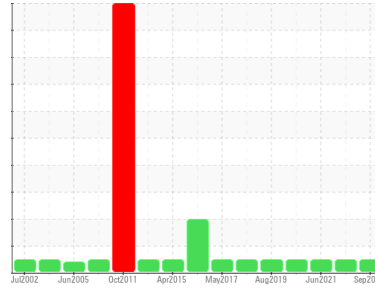
Sample Rating Trend

**NORMAL**

Resample at the next service interval to monitor.

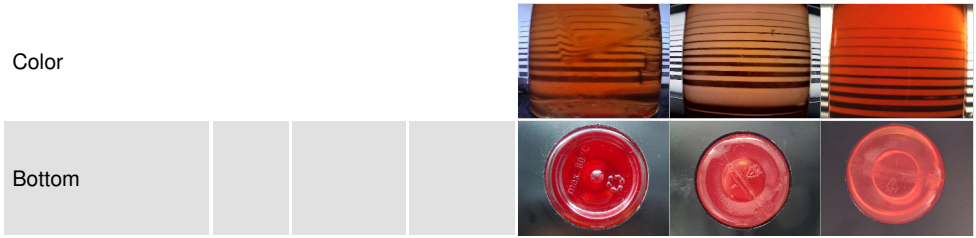
### SAMPLE IMAGES

VISUAL		method	limit/base	current	history1	history2
White Metal	scalar	Visual*	NONE	<b>NONE</b>	NONE	NONE
Yellow Metal	scalar	Visual*	NONE	<b>NONE</b>	NONE	NONE
Precipitate	scalar	Visual*	NONE	<b>NONE</b>	NONE	NONE
Silt	scalar	Visual*	NONE	<b>NONE</b>	NONE	NONE
Debris	scalar	Visual*	NONE	<b>NONE</b>	NONE	NONE
Sand/Dirt	scalar	Visual*	NONE	<b>NONE</b>	NONE	NONE
Appearance	scalar	Visual*	NORML	<b>NORML</b>	NORML	NORML
Odor	scalar	Visual*	NORML	<b>NORML</b>	NORML	NORML
Emulsified Water	scalar	Visual*	>2	<b>NEG</b>	NEG	NEG
Free Water	scalar	Visual*		<b>NEG</b>	NEG	NEG

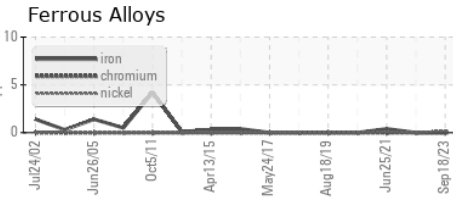
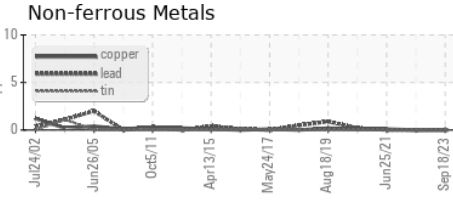
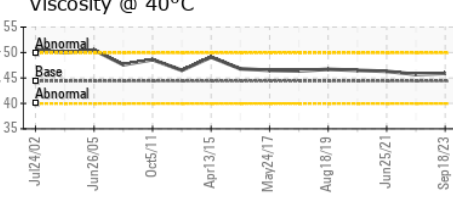
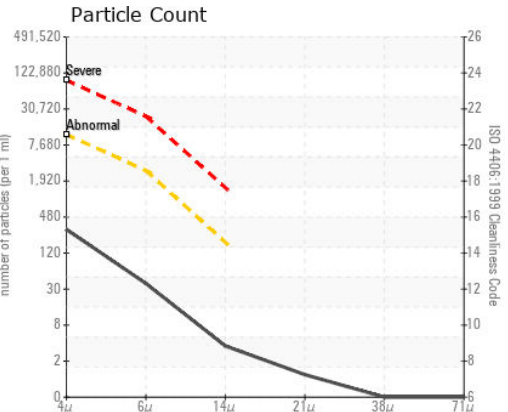
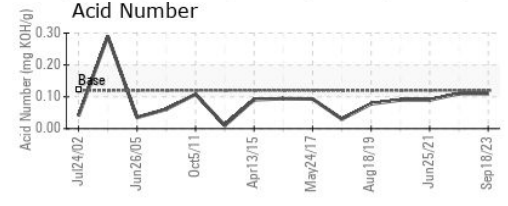
### GRAPHS

All component wear rates are normal.

The system cleanliness is acceptable for your target ISO 4406 cleanliness code. The system and fluid cleanliness is acceptable.

The AN level is acceptable for this fluid. The condition of the oil is suitable for further service.
