# OIL ANALYSIS REPORT

Area  
**SAB1**  
Machine Id  
**SAB1 G9**  
Component  
**Thrust Bearing**  
Fluid  
**ESSO TERESSO ISO 46 (4250 LTR)**

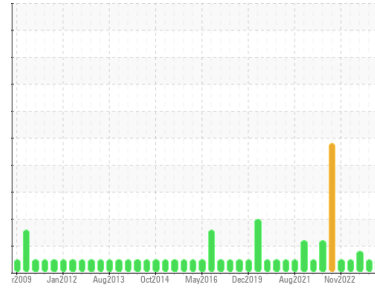
## Sample Rating Trend

**NORMAL**

Resample at the next service interval to monitor.

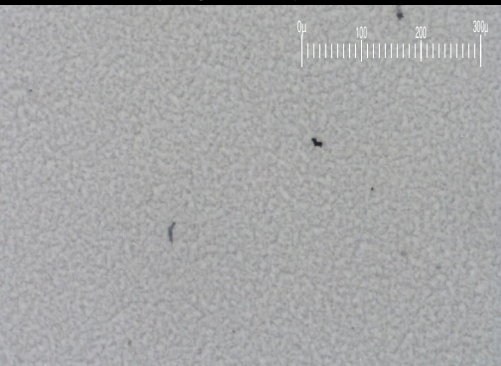
Particle Filter (Magn: 100 x)

The system cleanliness is acceptable for your target ISO 4406 cleanliness code. The system and fluid cleanliness is acceptable.
