# OIL ANALYSIS REPORT

Area  
**SAB1**  
Machine Id  
**SAB1 G3**  
Component  
**Turbine Bearing**  
Fluid  
**ESSO TERESSO ISO 46 (150 LTR)**

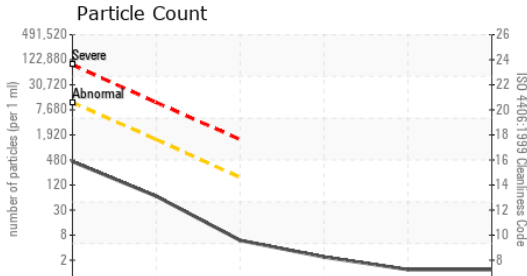
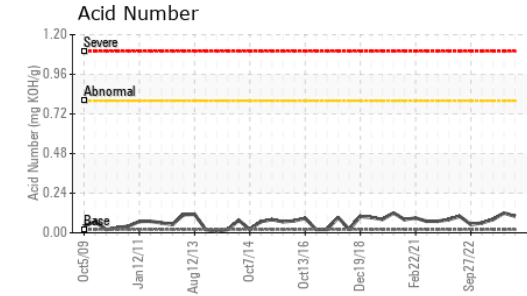
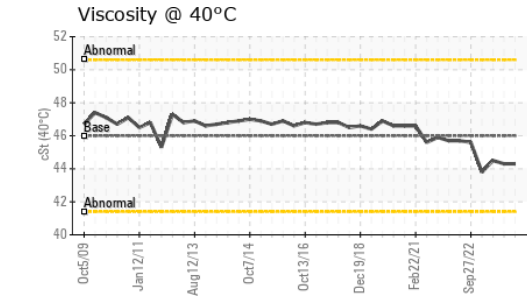
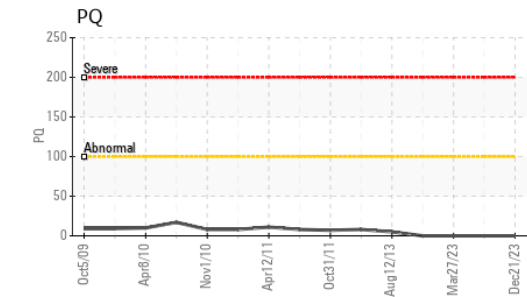
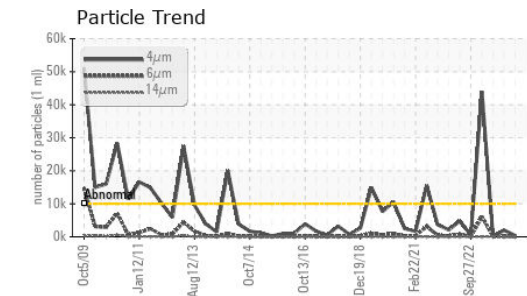
All component wear rates are normal.

The system cleanliness is acceptable for your target ISO 4406 cleanliness code. The system and fluid cleanliness is acceptable.

The AN level is acceptable for this fluid. The condition of the oil is suitable for further service.

Resample at the next service interval to monitor.

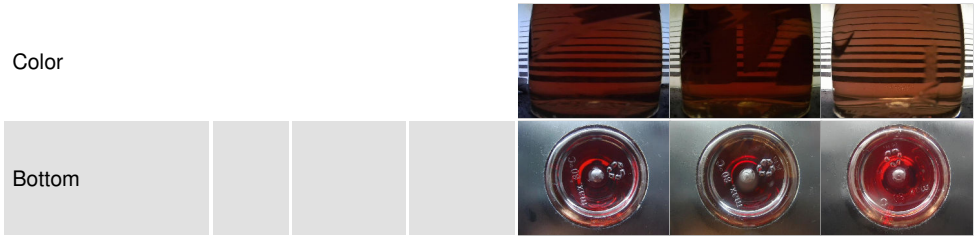
SAMPLE IMAGES	method	limit/base	current	history1	history2
---------------	--------	------------	---------	----------	----------

Color

Bottom
