OIL ANALYSIS REPORT

Machine Id
MTU PORT GEARBOX
Component
Port Gearbox
Fluid
SAE 15W40 (--- LTR)

Canadian Coast Guard
 93 BOUNDARY ST
 CLARK'S HARBOUR, NS
 CA B0W 1P0
 Contact: Service Manager
 CLARKS-HARBOUR.CCGS@dfp-mpo.gc.ca

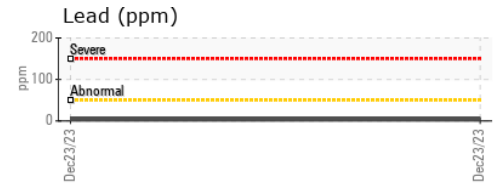
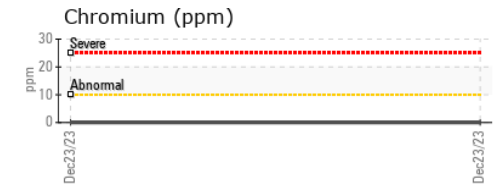
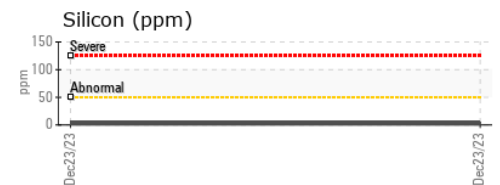
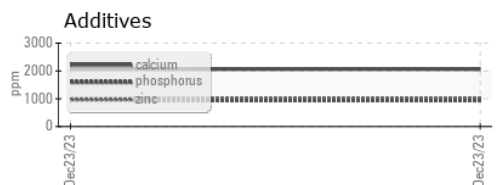
GRAPHS

Viscosity of sample indicates oil is within SAE 30 range, advise investigate. The condition of the oil is acceptable for the time in service.

FLUID PROPERTIES	method	limit/base	current	history1	history2	
Visc @ 40°C	cSt	ASTM D7279(m)	115	81.1	---	---

Resample at the next service interval to monitor.
