OIL ANALYSIS REPORT

Machine Id
33-LU-101 SAG MILL
 Component
Hydraulic System
 Fluid
SHELL OMALA S2 GX 220 (--- GAL)

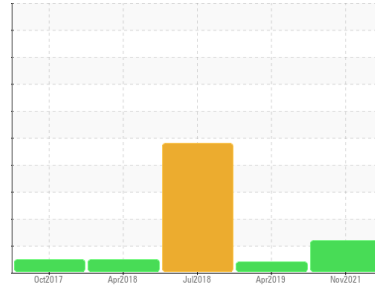
Sample Rating Trend

There is a moderate amount of silt (particulates < 14 microns in size) present in the oil.

We recommend you service the filters on this component. We recommend an early resample to monitor this condition. NOTE: Please provide information regarding reservoir capacity, filter type and micron rating with next sample.

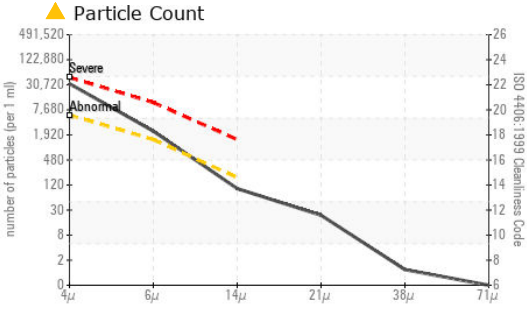
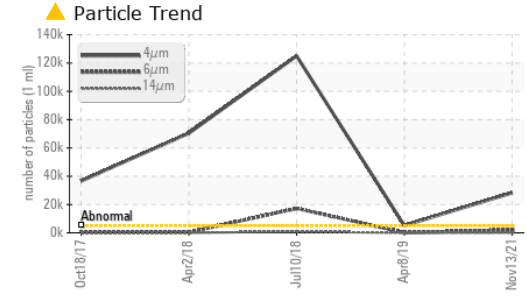
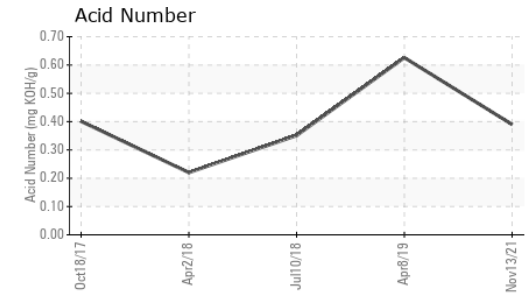
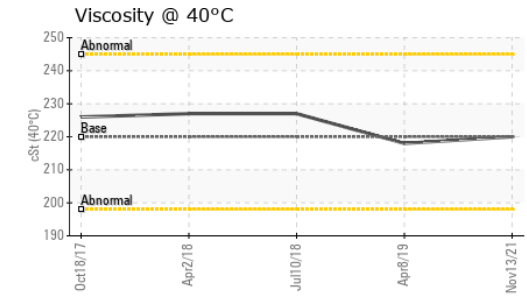
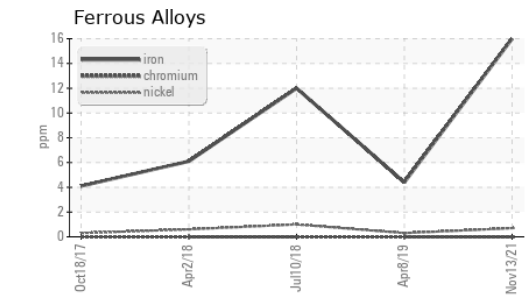
method	limit/base	current	history1	history2
Particles >4µm	ASTM D7647	>5000	▲ 28301	▲ 5088	● 124980
Particles >6µm	ASTM D7647	>1300	▲ 2067	83	● 17245
Particles >14µm	ASTM D7647	>160	87	3	▲ 851
Particles >21µm	ASTM D7647	>40	20	2	▲ 214
Particles >38µm	ASTM D7647	>10	1	1	2
Particles >71µm	ASTM D7647	>3	0	0	0
Oil Cleanliness	ISO 4406 (c)	>19/17/14	▲ 22/18/14	▲ 20/14/9	● 24/21/17
