OIL ANALYSIS REPORT

Area
SAB2
Machine Id
SAB2 G23
Component
Thrust Bearing
Fluid
ESSO TERESSO ISO 46 (3182 LTR)

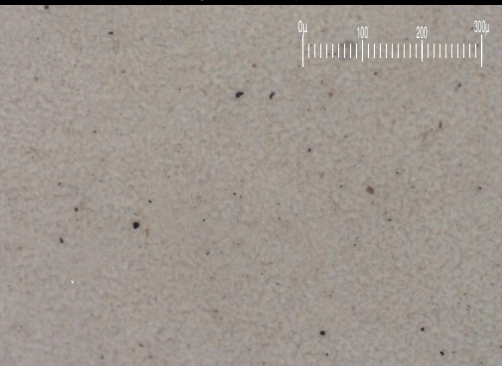
Particle Filter (Magn: 100 x)

There is a moderate amount of silt (particulates < 14 microns in size) present in the oil. The system cleanliness is above the acceptable limit for the target ISO 4406 cleanliness code.

We recommend you service the filters on this component. We recommend an early resample to monitor this condition. Please contact your representative for information regarding the proper sampling kits for your service. NOTE: We recommend using IND 3 test kits, this testkit includes Analytical Ferrography which provides a detailed morphological analysis of wear particles present in the fluid.
