OIL ANALYSIS REPORT

Area
SAB2
 Machine Id
SAB2 G16 Governor
 Component
Hydraulic System
 Fluid
ESSO TERESSO ISO 46 (6160 LTR)

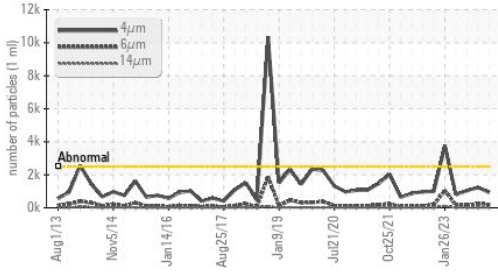
Particle Trend

method	limit/base	current	history1	history2
Particles >4µm	ASTM D7647 >2500	937	1232	1046
Particles >6µm	ASTM D7647 >640	205	224	183
Particles >14µm	ASTM D7647 >80	9	7	5
Particles >21µm	ASTM D7647 >20	2	2	1
Particles >38µm	ASTM D7647 >4	0	0	0
Particles >71µm	ASTM D7647 >3	0	0	0
Oil Cleanliness	ISO 4406 (c) >18/16/13	17/15/10	17/15/10	17/15/10

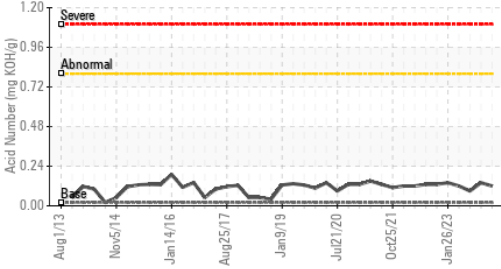
The AN level is acceptable for this fluid. The condition of the oil is suitable for further service.

FLUID DEGRADATION		method	limit/base	current	history1	history2
Acid Number (AN)	mg KOH/g	ASTM D974*	0.02	0.12	0.14	0.09

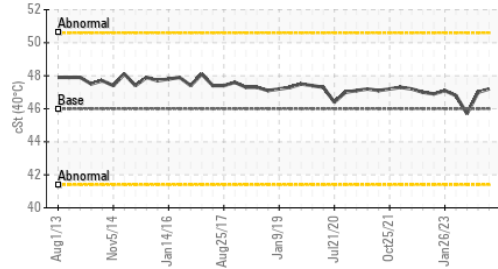
Viscosity @ 40°C

FLUID PROPERTIES		method	limit/base	current	history1	history2
Visc @ 40°C	cSt	ASTM D7279(m)	46	47.2	47.0	45.7

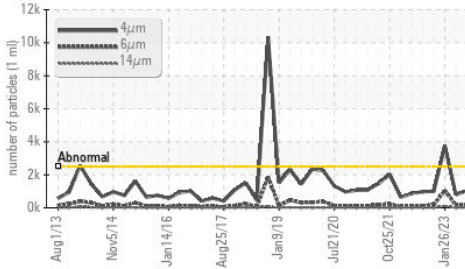
Particle Trend

The system cleanliness is acceptable for your target ISO 4406 cleanliness code. The system and fluid cleanliness is acceptable.

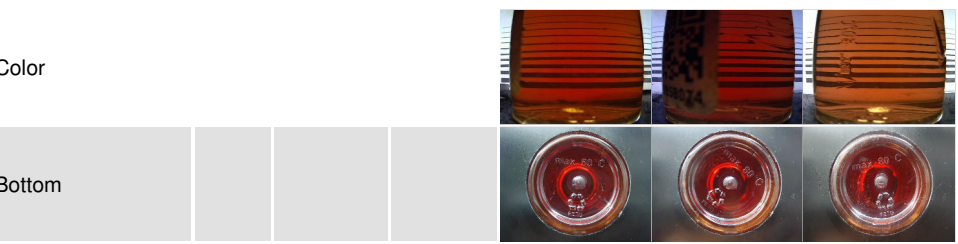
SAMPLE IMAGES

VISUAL		method	limit/base	current	history1	history2
White Metal	scalar	Visual*	NONE	NONE	NONE	NONE
Yellow Metal	scalar	Visual*	NONE	NONE	NONE	NONE
Precipitate	scalar	Visual*	NONE	NONE	NONE	NONE
Silt	scalar	Visual*	NONE	NONE	NONE	NONE
Debris	scalar	Visual*	NONE	NONE	NONE	NONE
Sand/Dirt	scalar	Visual*	NONE	NONE	NONE	NONE
Appearance	scalar	Visual*	NORML	NORML	NORML	NORML
Odor	scalar	Visual*	NORML	NORML	NORML	NORML
Emulsified Water	scalar	Visual*	>0.05	NEG	NEG	NEG
Free Water	scalar	Visual*		NEG	NEG	NEG
