# OIL ANALYSIS REPORT

Machine Id  
**SBK G1 GOV (S/N 627022)**

Component  
**Hydraulic System**

Fluid  
**ESSO TERESSO ISO 68 (40 GAL)**

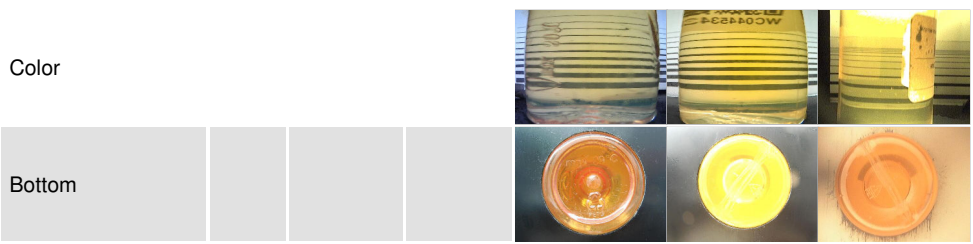
### SAMPLE IMAGES

VISUAL		method	limit/base	current	history1	history2
White Metal	scalar	Visual*	NONE	<b>NONE</b>	NONE	NONE
Yellow Metal	scalar	Visual*	NONE	<b>NONE</b>	NONE	NONE
Precipitate	scalar	Visual*	NONE	<b>NONE</b>	NONE	NONE
Silt	scalar	Visual*	NONE	<b>NONE</b>	NONE	NONE
Debris	scalar	Visual*	NONE	<b>NONE</b>	NONE	NONE
Sand/Dirt	scalar	Visual*	NONE	<b>NONE</b>	NONE	NONE
Appearance	scalar	Visual*	NORML	<b>NORML</b>	NORML	NORML
Odor	scalar	Visual*	NORML	<b>NORML</b>	NORML	NORML
Emulsified Water	scalar	Visual*	>0.05	<b>NEG</b>	NEG	NEG
Free Water	scalar	Visual*		<b>NEG</b>	NEG	NEG

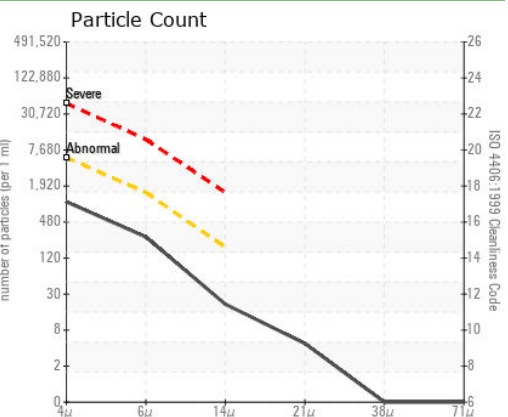
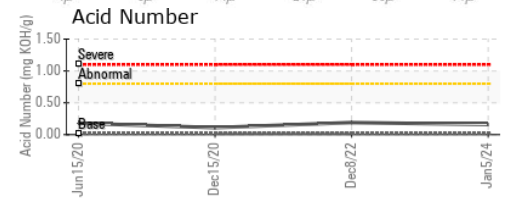
### GRAPHS

FLUID CLEANLINESS		method	limit/base	current	history1	history2
Particles >4µm		ASTM D7647	>5000	<b>918</b>	411	882
Particles >6µm		ASTM D7647	>1300	<b>238</b>	98	211
Particles >14µm		ASTM D7647	>160	<b>18</b>	12	35
Particles >21µm		ASTM D7647	>40	<b>4</b>	4	14
Particles >38µm		ASTM D7647	>10	<b>0</b>	0	2
Particles >71µm		ASTM D7647	>3	<b>0</b>	0	0
Oil Cleanliness		ISO 4406 (c)	>19/17/14	<b>17/15/11</b>	16/14/11	17/15/12

FLUID PROPERTIES		method	limit/base	current	history1	history2
Visc @ 40°C	cSt	ASTM D7279(m)	68	<b>66.5</b>	67.2	67.4
