OIL ANALYSIS REPORT

Area
6 Calender Line
 Machine Id
39-0290 HB mill

Component
Gearbox
 Fluid
SUNOCO SUNE320 (140 LTR)

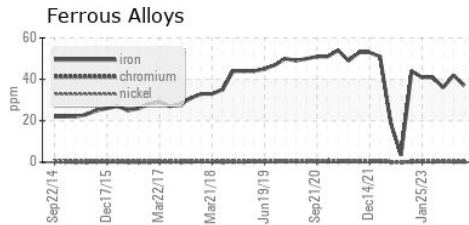
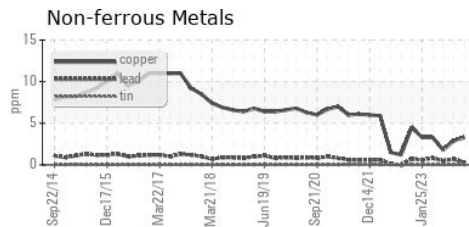
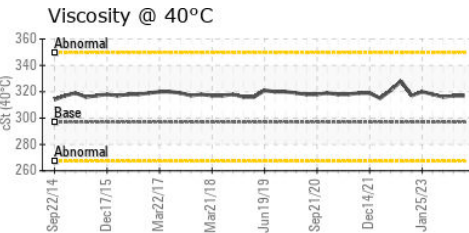
GRAPHS

All component wear rates are normal.

There is no indication of any contamination in the oil.

The condition of the oil is acceptable for the time in service.

Resample at the next service interval to monitor.
