OIL ANALYSIS REPORT

Area
3 Calender Line
 Machine Id
GBOILPMP Calender GB
 Component
Gearbox
 Fluid
SUNOCO SUNE320 (200 GAL)

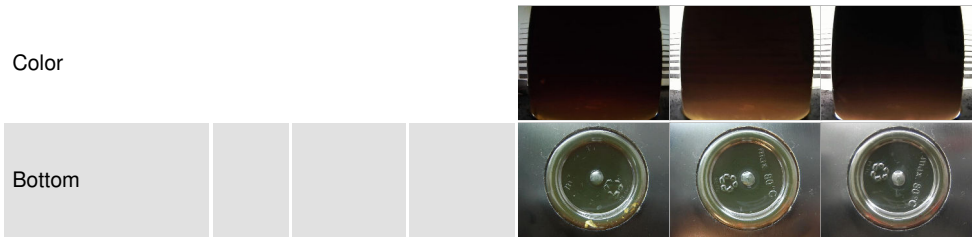
SAMPLE IMAGES	method	limit/base	current	history1	history2
---------------	--------	------------	---------	----------	----------

VISUAL	method	limit/base	current	history1	history2
White Metal	scalar	Visual*	NONE	NONE	NONE
Yellow Metal	scalar	Visual*	NONE	NONE	NONE
Precipitate	scalar	Visual*	NONE	NONE	NONE
Silt	scalar	Visual*	NONE	NONE	NONE
Debris	scalar	Visual*	NONE	NONE	NONE
Sand/Dirt	scalar	Visual*	NONE	NONE	NONE
Appearance	scalar	Visual*	NORML	NORML	NORML
Odor	scalar	Visual*	NORML	NORML	NORML
Emulsified Water	scalar	Visual*	>0.2	NEG	NEG
Free Water	scalar	Visual*		NEG	NEG

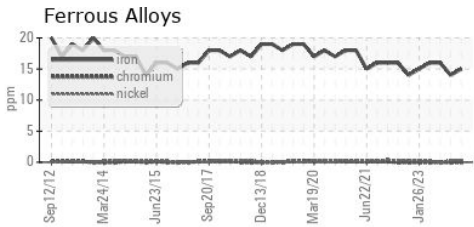
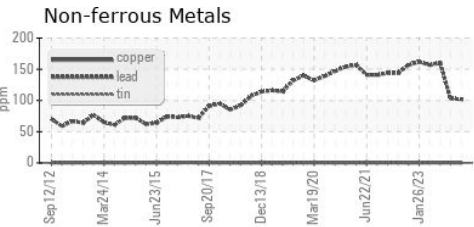
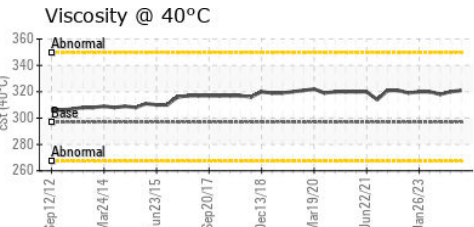
GRAPHS

All component wear rates are normal.

There is no indication of any contamination in the oil.

The condition of the oil is acceptable for the time in service.

Resample at the next service interval to monitor.
