OIL ANALYSIS REPORT

Area
3 Calender Line
 Machine Id
42-0384 Banbury

Component
Gearbox
 Fluid
SUNOCO SUNE320 (51 GAL)

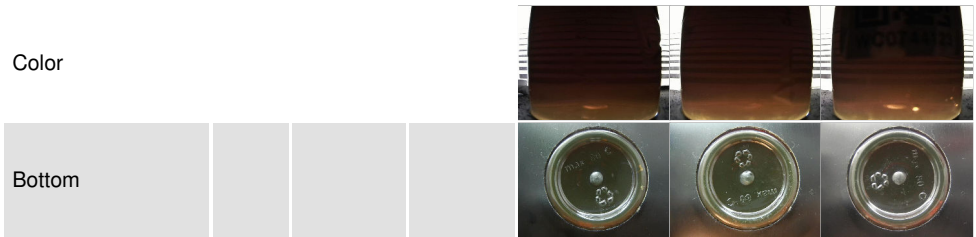
SAMPLE IMAGES	method	limit/base	current	history1	history2
---------------	--------	------------	---------	----------	----------

VISUAL	method	limit/base	current	history1	history2
White Metal	scalar	Visual*	NONE	NONE	NONE
Yellow Metal	scalar	Visual*	NONE	NONE	NONE
Precipitate	scalar	Visual*	NONE	NONE	NONE
Silt	scalar	Visual*	NONE	NONE	NONE
Debris	scalar	Visual*	NONE	NONE	NONE
Sand/Dirt	scalar	Visual*	NONE	NONE	NONE
Appearance	scalar	Visual*	NORML	NORML	NORML
Odor	scalar	Visual*	NORML	NORML	NORML
Emulsified Water	scalar	Visual*	>0.2	NEG	NEG
Free Water	scalar	Visual*		NEG	NEG

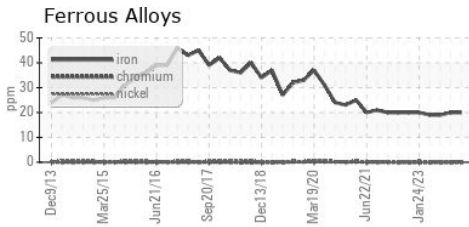
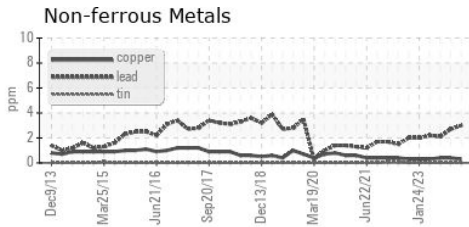
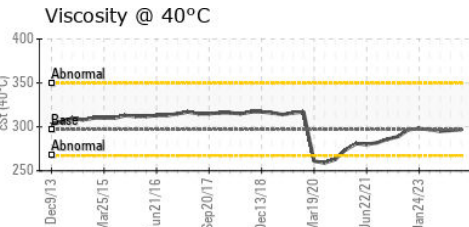
GRAPHS

All component wear rates are normal.

There is no indication of any contamination in the oil.

The condition of the oil is acceptable for the time in service.

Resample at the next service interval to monitor.
