OIL ANALYSIS REPORT

Area
3 Calender Line
 Machine Id
49-0003 Spare Banbury
 Component
Gearbox
 Fluid
SUNOCO SUNE32 (30 GAL)

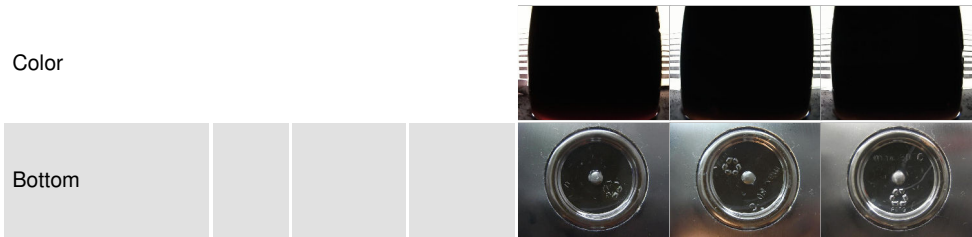
SAMPLE IMAGES	method	limit/base	current	history1	history2
---------------	--------	------------	---------	----------	----------

VISUAL	method	limit/base	current	history1	history2
White Metal	scalar	Visual*	NONE	NONE	NONE
Yellow Metal	scalar	Visual*	NONE	NONE	NONE
Precipitate	scalar	Visual*	NONE	NONE	NONE
Silt	scalar	Visual*	NONE	NONE	NONE
Debris	scalar	Visual*	NONE	NONE	NONE
Sand/Dirt	scalar	Visual*	NONE	VLITE	NONE
Appearance	scalar	Visual*	NORML	NORML	NORML
Odor	scalar	Visual*	NORML	NORML	NORML
Emulsified Water	scalar	Visual*	>0.2	NEG	NEG
Free Water	scalar	Visual*		NEG	NEG

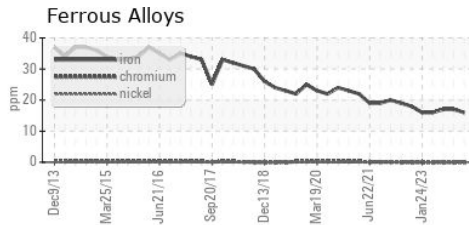
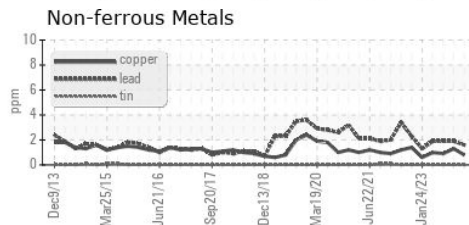
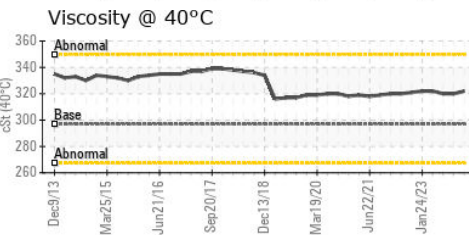
GRAPHS

All component wear rates are normal.

There is no indication of any contamination in the oil.

The condition of the oil is acceptable for the time in service.

Resample at the next service interval to monitor.
