OIL ANALYSIS REPORT

Area
CONSTRUCTION POLARIS CMM INC [02608014]
 Machine Id
CATERPILLAR 336D 5550 (S/N W3K01110)
 Component
Hydraulic System
 Fluid
PANOLIN HLP SYNTH 46 (--- GAL)

MINERAL OIL CONTENT REPORT

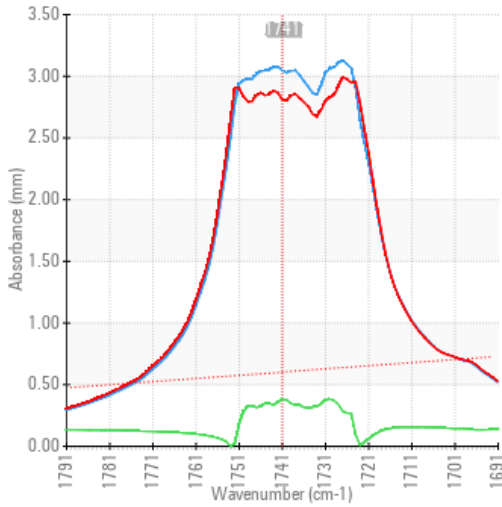
FT-IR - Esters I

Il y a une faible concentration (<5.0%) d'huile minérale présente dans le fluide. La propreté du système est acceptable pour votre objectif de propreté ISO 4406. La teneur en eau est négligeable. La propreté du système et du fluide est acceptable.
