OIL ANALYSIS REPORT

Machine Id
CATERPILLAR R1300 SCP228
 Component
Transmission (Auto)
 Fluid
{not provided} (--- GAL)

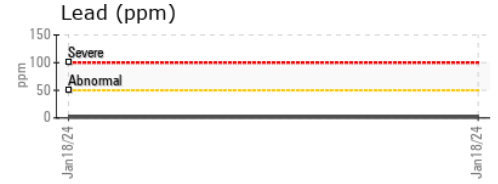
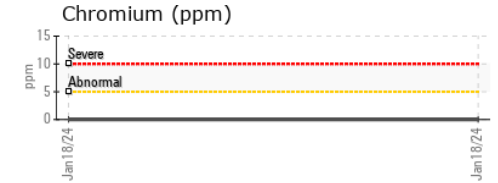
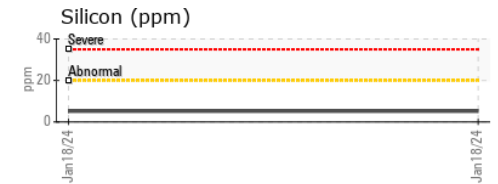
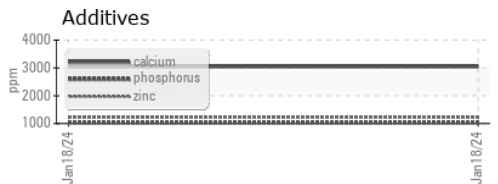
GRAPHS

All component wear rates are normal.

There is no indication of any contamination in the fluid.

The condition of the fluid is acceptable for the time in service.

Resample at the next service interval to monitor.
 Please specify the brand, type, and viscosity of the oil on your next sample.
