OIL ANALYSIS REPORT

Machine Id
EPIROC MT65 TRK 219

Component
Front Differential

Fluid
PENNZOIL SYNTHETIC SAE 75W140 GL-5 (--- GAL)

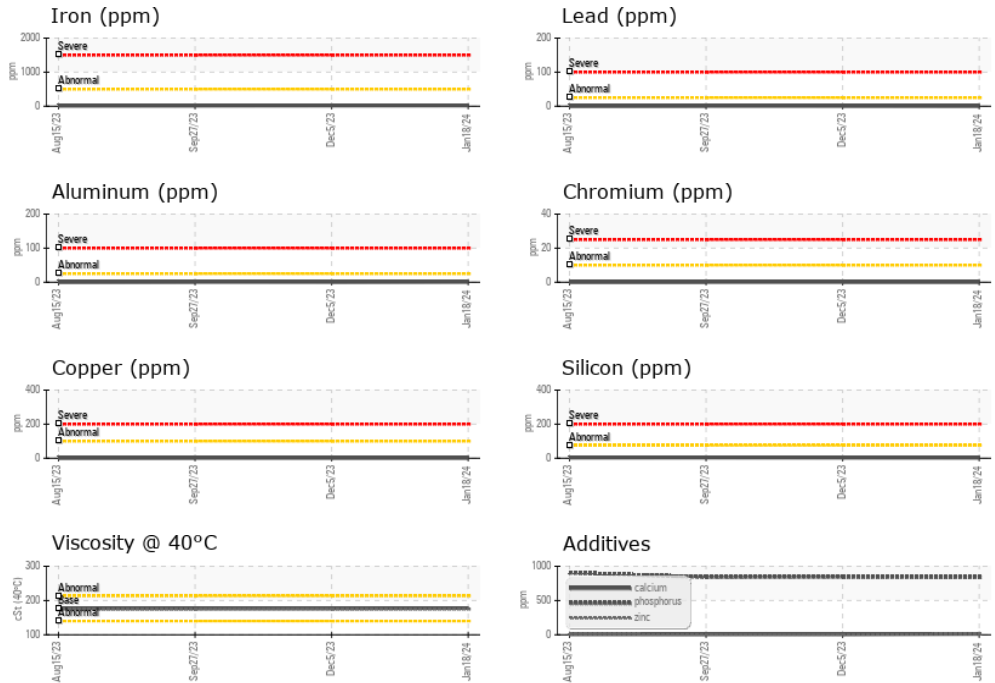
GRAPHS

All component wear rates are normal.

There is no indication of any contamination in the oil.

The condition of the oil is acceptable for the time in service.

Resample at the next service interval to monitor.
