OIL ANALYSIS REPORT

Machine Id
EPIROC ST18 SCP203

Component
Drop Box
Fluid
SAE 75W140 (--- GAL)

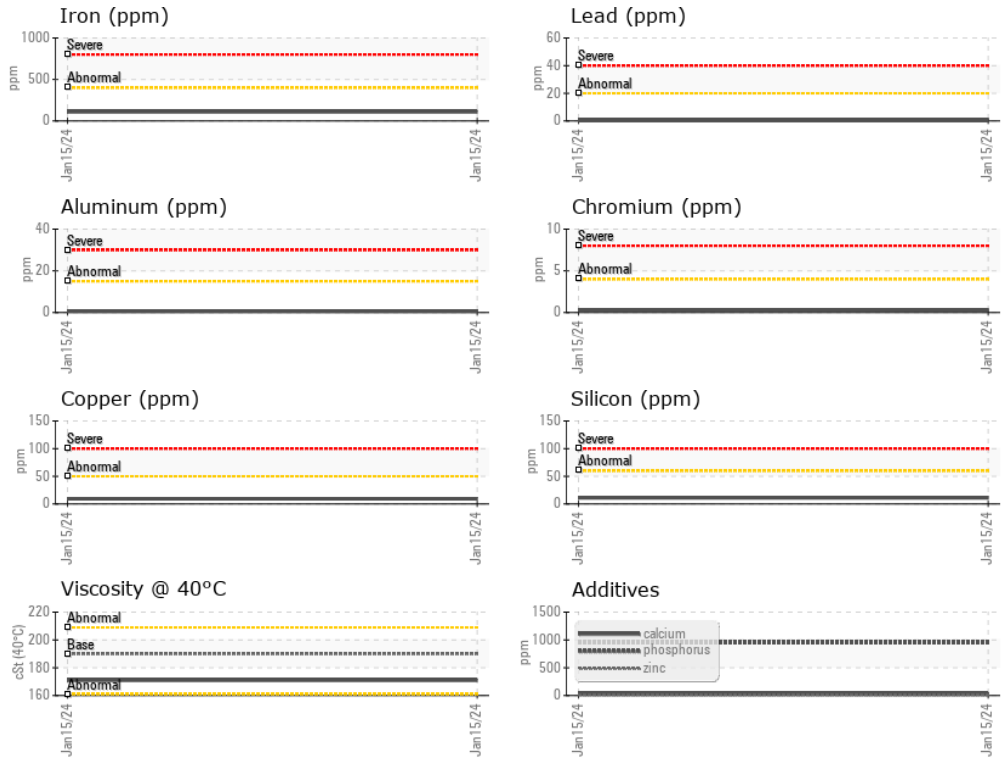
GRAPHS

All component wear rates are normal.

There is no indication of any contamination in the oil.

The condition of the oil is acceptable for the time in service.

Resample at the next service interval to monitor.
