OIL ANALYSIS REPORT

ORIN CONTRACTORS **378**

Right Final Drive

PETRO CANADA TRAXON 80W90 (--- GAL)

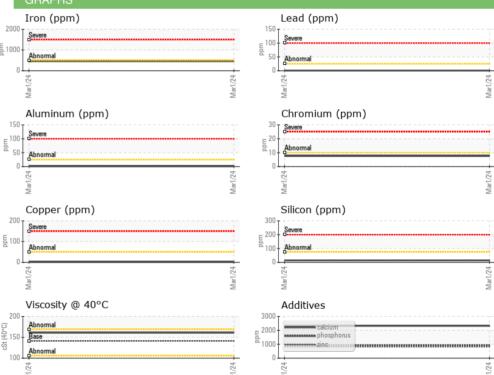
SAMPLE IMAGES	method	limit/base	current	history1	history2
Color			J	no image	no image
Bottom				no image	no image
GRAPHS					
Iron (ppm)			Lead (ppm)
