OIL ANALYSIS REPORT

Area
ORIN CONTRACTORS
 Machine Id
183
 Component
Left Swing Drive
 Fluid
PETRO CANADA 30W (--- GAL)

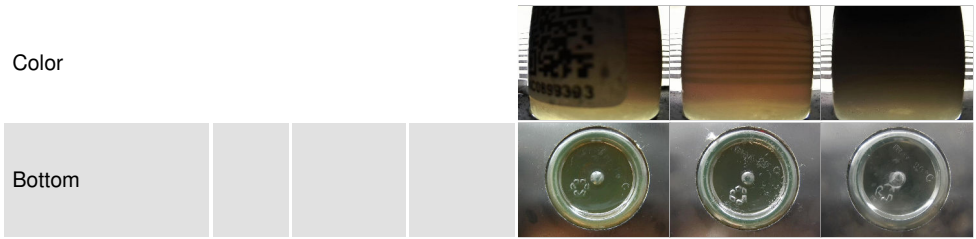
SAMPLE IMAGES	method	limit/base	current	history1	history2
---------------	--------	------------	---------	----------	----------

VISUAL	method	limit/base	current	history1	history2
White Metal	scalar	Visual*	NONE	NONE	NONE
Yellow Metal	scalar	Visual*	NONE	NONE	NONE
Precipitate	scalar	Visual*	NONE	NONE	NONE
Silt	scalar	Visual*	NONE	NONE	NONE
Debris	scalar	Visual*	NONE	NONE	NONE
Sand/Dirt	scalar	Visual*	NONE	NONE	NONE
Appearance	scalar	Visual*	NORML	NORML	NORML
Odor	scalar	Visual*	NORML	NORML	NORML
Emulsified Water	scalar	Visual*	>0.25	NEG	NEG
Free Water	scalar	Visual*		NEG	NEG

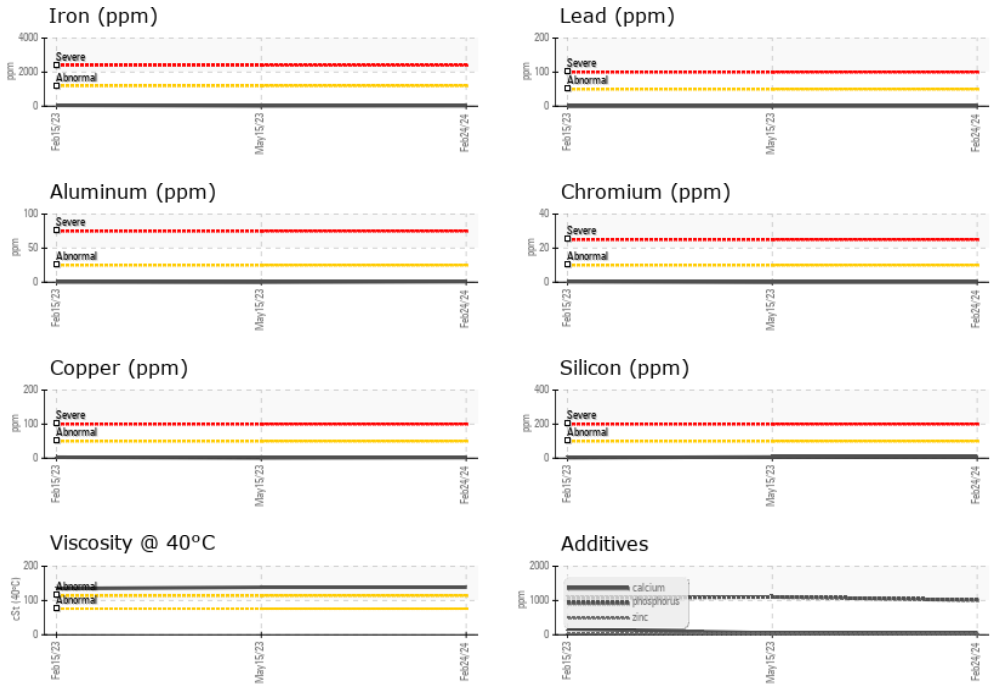
GRAPHS

All component wear rates are normal.

There is no indication of any contamination in the oil.

The condition of the oil is acceptable for the time in service.

Resample at the next service interval to monitor.
