OIL ANALYSIS REPORT

RONI 9-101 Component

Rear Left Final Drive

PETRO CANADA 50W (--- GAL)

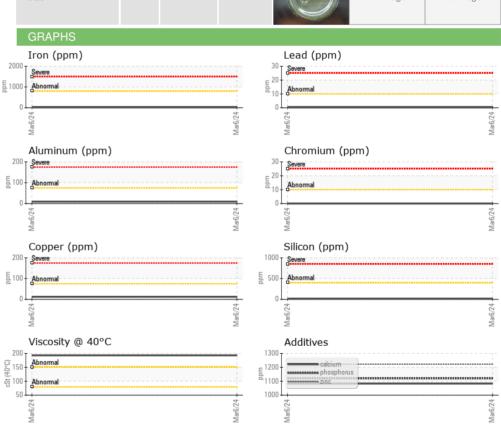
SAMPLE IMAGES	metnoa	ilmit/base	current	nistory i	nistory2
Color				no image	no image
Bottom			(C)*	no image	no image
GRAPHS
