OIL ANALYSIS REPORT

Machine Id
CATERPILLAR 740GL HDTR0836
 Component
Transmission (Manual)
 Fluid
MOBIL TO 4 10 (--- GAL)

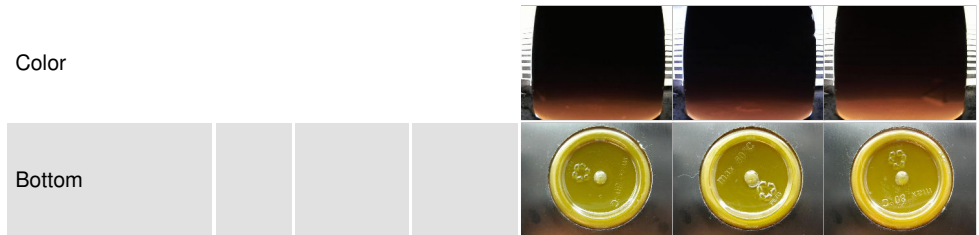
SAMPLE IMAGES	method	limit/base	current	history1	history2
---------------	--------	------------	---------	----------	----------

VISUAL	method	limit/base	current	history1	history2
White Metal	scalar	Visual*	NONE	NONE	VLITE
Yellow Metal	scalar	Visual*	NONE	NONE	NONE
Precipitate	scalar	Visual*	NONE	NONE	NONE
Silt	scalar	Visual*	NONE	NONE	NONE
Debris	scalar	Visual*	NONE	NONE	NONE
Sand/Dirt	scalar	Visual*	NONE	NONE	NONE
Appearance	scalar	Visual*	NORML	NORML	NORML
Odor	scalar	Visual*	NORML	NORML	NORML
Emulsified Water	scalar	Visual*	>0.1	NEG	NEG
Free Water	scalar	Visual*		NEG	NEG

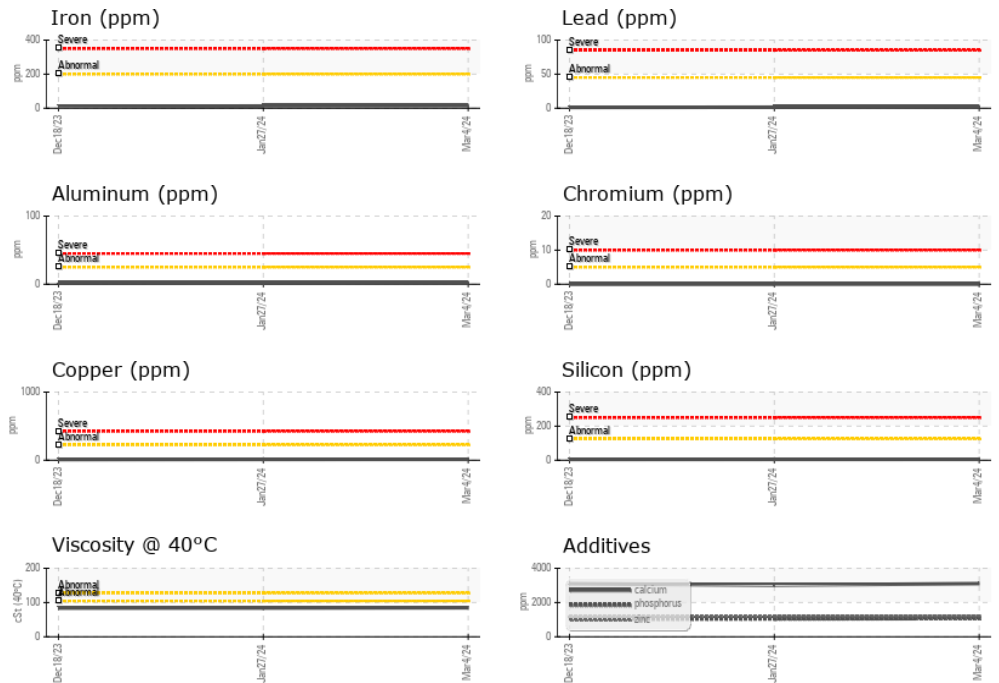
GRAPHS

All component wear rates are normal.

There is no indication of any contamination in the fluid.

The condition of the fluid is acceptable for the time in service.

Resample at the next service interval to monitor.
