# OIL ANALYSIS REPORT

Machine Id  
**OPG ICD GATE #4**

Component  
**Hydraulic System**

Fluid  
**MOBIL VELOCITE OIL NO.10 (3500 LTR)**

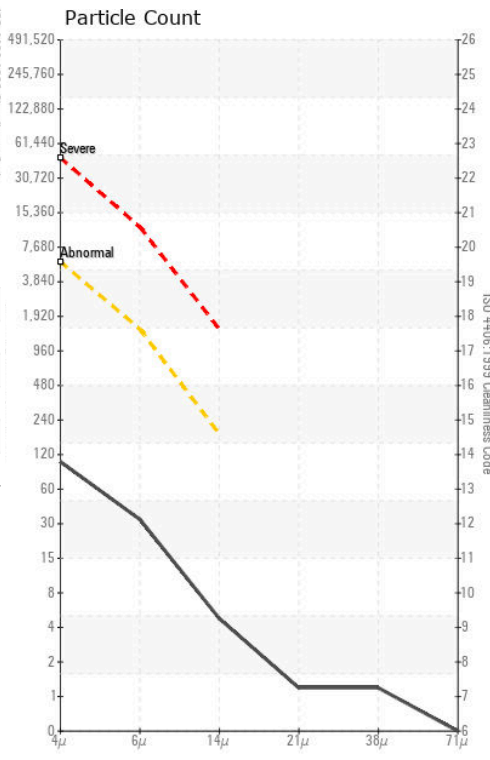
## GRAPHS

ISO Cleanliness Code (ISO 4406:1999): 14/12/9;  
Cumulative particle counts >4µm = 92, >6µm = 29,  
>14µm = 4, >21µm = 1, >38µm = 1, >71µm = 0.
