CLEANLINESS TEST REPORT

Part Number
AT416560
Component
Hose Assembly
Fluid
KEROSENE (--- mL)

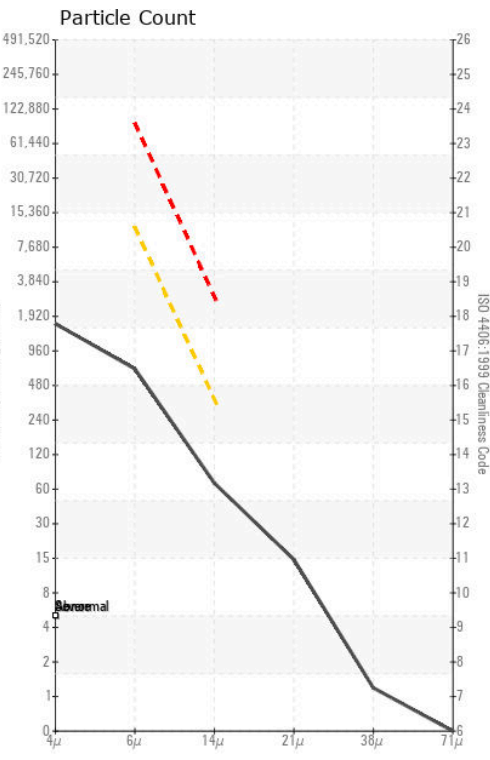
GRAPHS

method	limit/base	current	history1	history2
Particles >4µm	ASTM D7647		1451	---	---
Particles >6µm	ASTM D7647	>10000	588	---	---
Particles >14µm	ASTM D7647	>320	60	---	---
Particles >21µm	ASTM D7647	>80	13	---	---
Particles >38µm	ASTM D7647	>20	1	---	---
Particles >71µm	ASTM D7647	>4	0	---	---
Oil Cleanliness	ISO 4406 (c)	>--/20/15	18/16/13	---	---
