CLEANLINESS TEST REPORT

Part Number
AT549168
Component
Hose Assembly
Fluid
KEROSENE (--- mL)

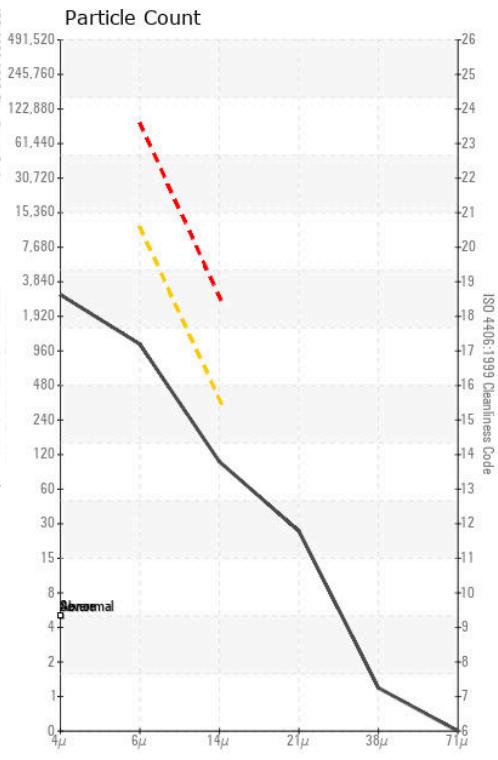
GRAPHS

method	limit/base	current	history1	history2
Particles >4µm	ASTM D7647		2592	---	---
Particles >6µm	ASTM D7647	>10000	962	---	---
Particles >14µm	ASTM D7647	>320	92	---	---
Particles >21µm	ASTM D7647	>80	23	---	---
Particles >38µm	ASTM D7647	>20	1	---	---
Particles >71µm	ASTM D7647	>4	0	---	---
Oil Cleanliness	ISO 4406 (c)	>--/20/15	19/17/14	---	---
