CLEANLINESS TEST REPORT

Part Number
AT553281
Component
Hose Assembly
Fluid
KEROSENE (--- mL)

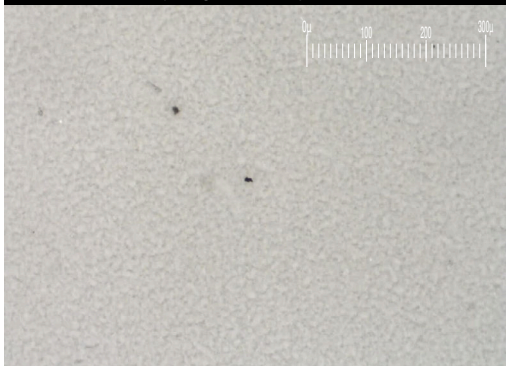
Particle Filter (Magn: 100 x)

The system cleanliness is acceptable for your target ISO 4406 cleanliness code. Cleanliness as per JDS-G169 Fluid Cleanliness Class 5.4 (ISO 4406 --/20/15).

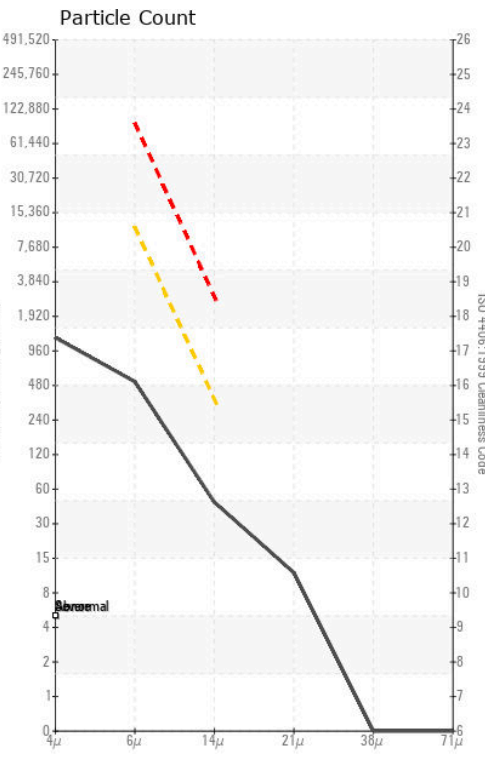
GRAPHS

method	limit/base	current	history1	history2
Particles >4µm	ASTM D7647		1096	---	---
Particles >6µm	ASTM D7647	>10000	455	---	---
Particles >14µm	ASTM D7647	>320	41	---	---
Particles >21µm	ASTM D7647	>80	10	---	---
Particles >38µm	ASTM D7647	>20	0	---	---
Particles >71µm	ASTM D7647	>4	0	---	---
Oil Cleanliness	ISO 4406 (c)	>--/20/15	17/16/13	---	---
