OIL ANALYSIS REPORT

Area
315 Nantucket
 Machine Id
G3
 Component
Hydraulic System
 Fluid
AW HYDRAULIC OIL ISO 46 (--- LTR)

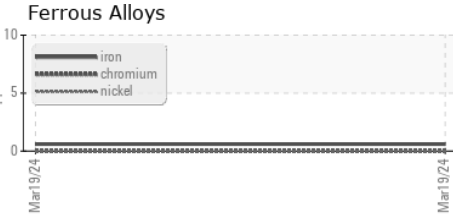
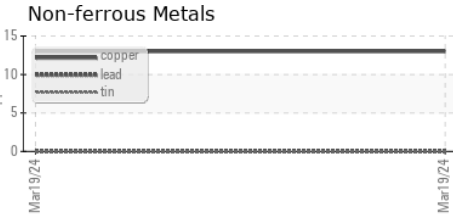
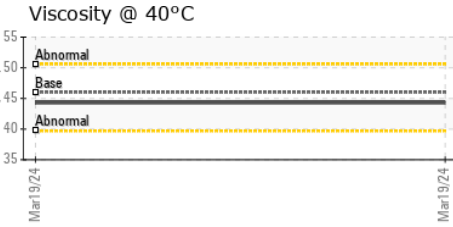
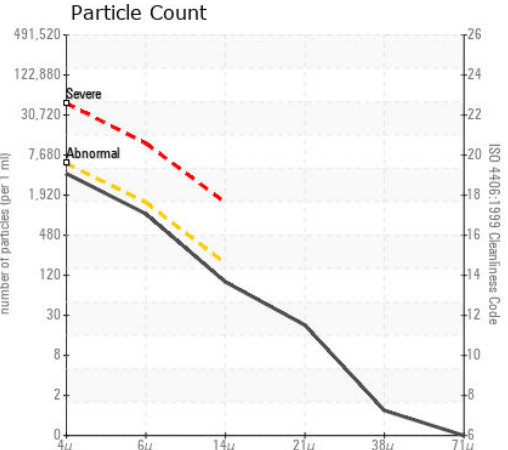
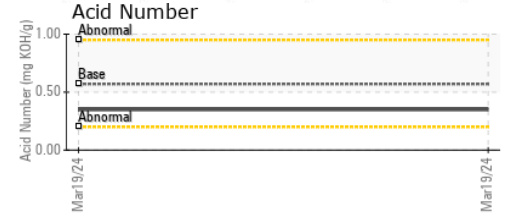
GRAPHS

All component wear rates are normal.

The system cleanliness is acceptable for your target ISO 4406 cleanliness code. The system and fluid cleanliness is acceptable.

The AN level is acceptable for this fluid. The condition of the oil is suitable for further service.
