OIL ANALYSIS REPORT

Area
Linamar Coop - T01200
 Machine Id
A2403143
 Component
Quench Oil
 Fluid
{not provided} (--- GAL)

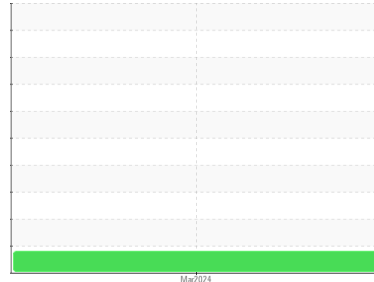
Sample Rating Trend

- Recommendation**
This is a baseline read-out on the submitted sample.
- Wear**
Iron ppm levels are noted.

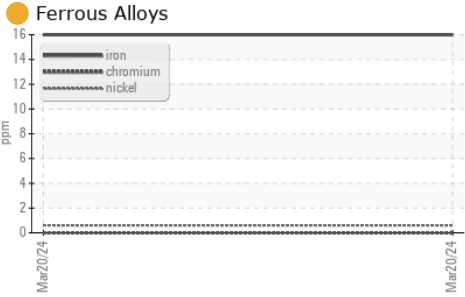
GRAPHS

method	limit/base	current	history1	history2
Iron	ppm	ASTM D5185(m)	16	---	---
Chromium	ppm	ASTM D5185(m)	0	---	---
Nickel	ppm	ASTM D5185(m)	<1	---	---
Titanium	ppm	ASTM D5185(m)	0	---	---
Silver	ppm	ASTM D5185(m)	0	---	---
Aluminum	ppm	ASTM D5185(m)	0	---	---
Lead	ppm	ASTM D5185(m)	0	---	---
Copper	ppm	ASTM D5185(m)	5	---	---
Tin	ppm	ASTM D5185(m)	0	---	---
Antimony	ppm	ASTM D5185(m)	0	---	---
Vanadium	ppm	ASTM D5185(m)	0	---	---
Beryllium	ppm	ASTM D5185(m)	0	---	---
Cadmium	ppm	ASTM D5185(m)	0	---	---
