OIL ANALYSIS REPORT

Area
RONI
 Machine Id
455

Component
Transmission (Manual)

Fluid
JOHN DEERE HY-GARD HYD/TRANS (--- GAL)

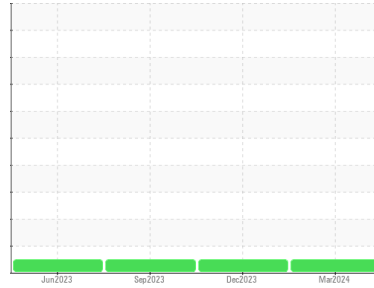
NORMAL

All component wear rates are normal.

There is no indication of any contamination in the fluid.

The condition of the fluid is acceptable for the time in service.

Resample at the next service interval to monitor.

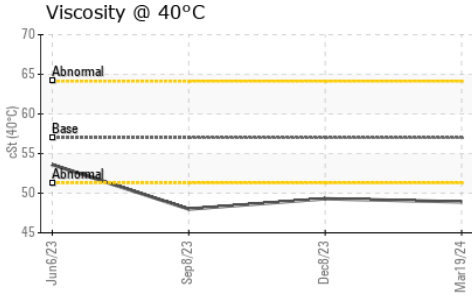
VISUAL	method	limit/base	current	history1	history2
White Metal	scalar	Visual*	NONE	NONE	NONE
Yellow Metal	scalar	Visual*	NONE	NONE	NONE
Precipitate	scalar	Visual*	NONE	NONE	NONE
Silt	scalar	Visual*	NONE	NONE	NONE
Debris	scalar	Visual*	NONE	NONE	NONE
Sand/Dirt	scalar	Visual*	NONE	NONE	NONE
Appearance	scalar	Visual*	NORML	NORML	NORML
Odor	scalar	Visual*	NORML	NORML	NORML
Emulsified Water	scalar	Visual*	>0.1	NEG	NEG
Free Water	scalar	Visual*		NEG	NEG

FLUID PROPERTIES	method	limit/base	current	history1	history2	
Visc @ 40°C	cSt	ASTM D7279(m)	57.0	48.9	49.3	48.0

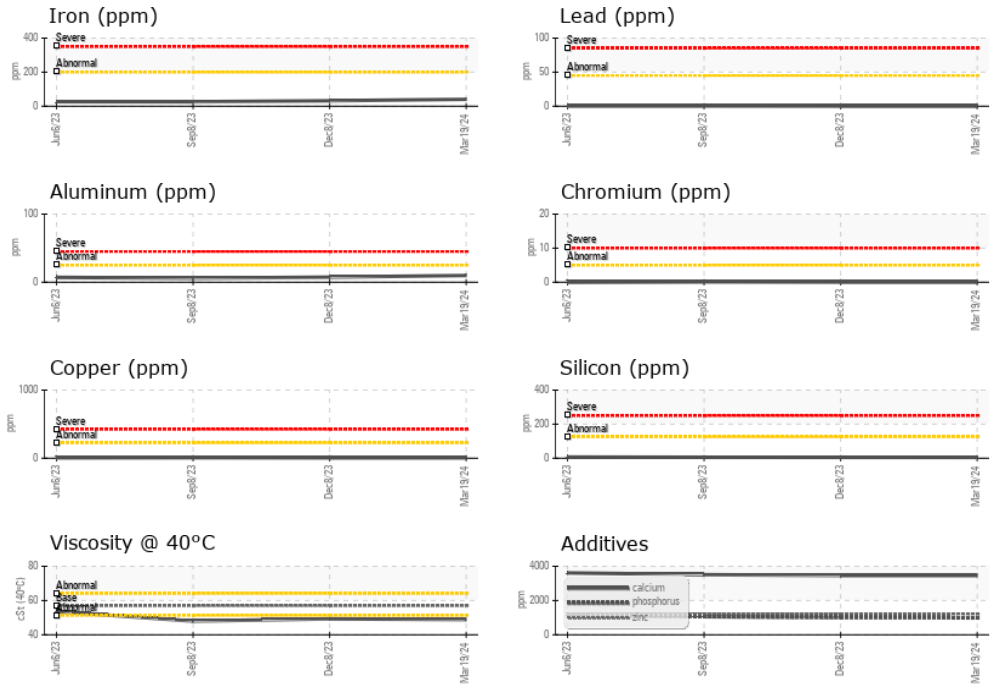
GRAPHS

method	limit/base	current	history1	history2	
Iron	ppm	ASTM D5185(m)	>200	41	32	26
Chromium	ppm	ASTM D5185(m)	>5	0	0	<1
Nickel	ppm	ASTM D5185(m)	>5	0	<1	<1
Titanium	ppm	ASTM D5185(m)		0	0	0
Silver	ppm	ASTM D5185(m)	>7	0	<1	0
Aluminum	ppm	ASTM D5185(m)	>25	10	7	6
Lead	ppm	ASTM D5185(m)	>45	0	0	<1
Copper	ppm	ASTM D5185(m)	>225	5	5	8
Tin	ppm	ASTM D5185(m)	>10	0	0	0
Antimony	ppm	ASTM D5185(m)		0	0	0
Vanadium	ppm	ASTM D5185(m)		0	0	0
Beryllium	ppm	ASTM D5185(m)		0	0	0
Cadmium	ppm	ASTM D5185(m)		0	0	0
