OIL ANALYSIS REPORT

Area
RONI
 Machine Id
455
 Component
Rear Left Final Drive
 Fluid
JOHN DEERE HY-GARD HYD/TRANS (--- GAL)

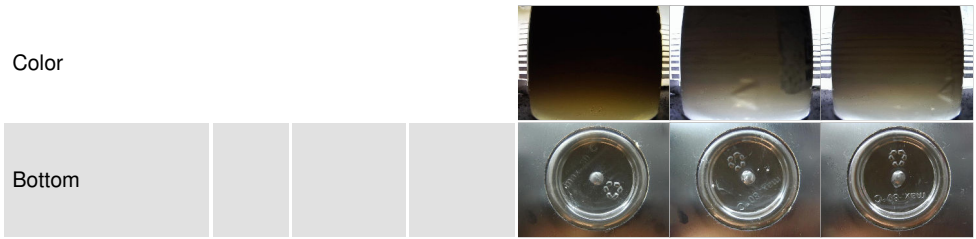
SAMPLE IMAGES	method	limit/base	current	history1	history2
---------------	--------	------------	---------	----------	----------

VISUAL	method	limit/base	current	history1	history2
White Metal	scalar	Visual*	NONE	NONE	NONE
Yellow Metal	scalar	Visual*	NONE	NONE	NONE
Precipitate	scalar	Visual*	NONE	NONE	NONE
Silt	scalar	Visual*	NONE	NONE	NONE
Debris	scalar	Visual*	NONE	NONE	NONE
Sand/Dirt	scalar	Visual*	NONE	NONE	NONE
Appearance	scalar	Visual*	NORML	NORML	NORML
Odor	scalar	Visual*	NORML	NORML	NORML
Emulsified Water	scalar	Visual*	>0.075	NEG	NEG
Free Water	scalar	Visual*		NEG	NEG

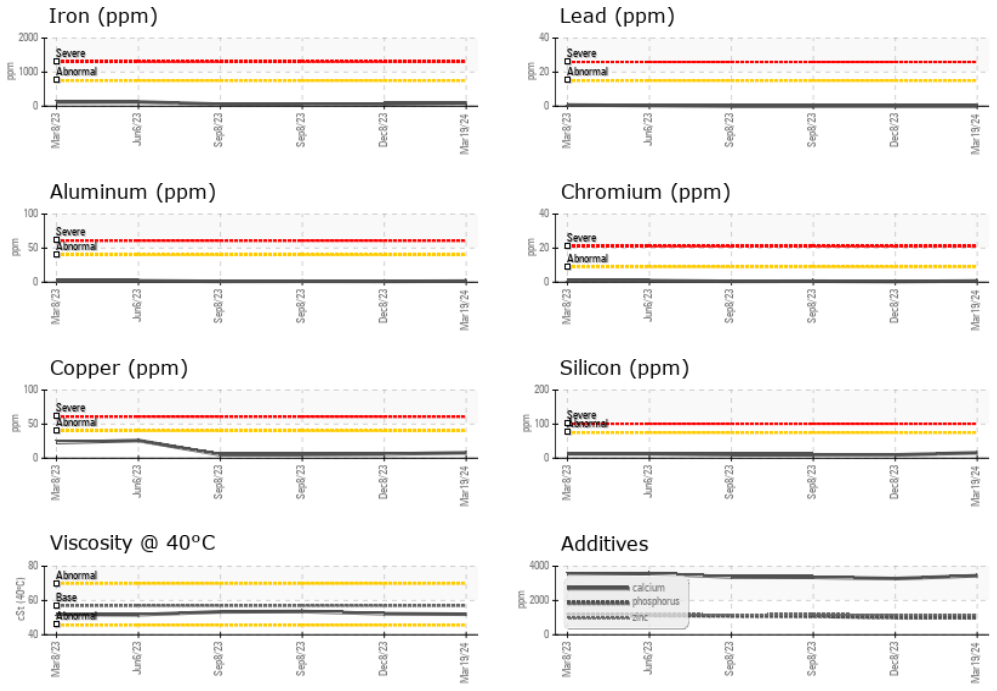
GRAPHS

method	limit/base	current	history1	history2
Iron	ppm	ASTM D5185(m) >750	94	64	57
Chromium	ppm	ASTM D5185(m) >9	<1	<1	<1
Nickel	ppm	ASTM D5185(m) >10	2	2	2
Titanium	ppm	ASTM D5185(m)	0	0	<1
Silver	ppm	ASTM D5185(m)	0	<1	0
Aluminum	ppm	ASTM D5185(m) >40	2	1	1
Lead	ppm	ASTM D5185(m) >15	0	0	0
Copper	ppm	ASTM D5185(m) >40	8	6	5
Tin	ppm	ASTM D5185(m) >10	0	0	0
Antimony	ppm	ASTM D5185(m) >5	0	0	0
Vanadium	ppm	ASTM D5185(m)	0	0	0
Beryllium	ppm	ASTM D5185(m)	0	0	0
Cadmium	ppm	ASTM D5185(m)	0	0	0
