# OIL ANALYSIS REPORT

Machine Id  
**NO UNIT WC0915116**

Component  
**Hydraulic System**

Fluid  
**PETRO CANADA PRODURO TO-4 SAE 50 (--- GAL)**

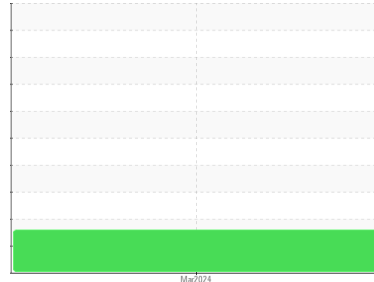
Sample Rating Trend

**DIRT**

There is a moderate concentration of dirt present in the oil.

The oil is no longer serviceable due to the presence of contaminants.

We advise that you check all areas where dirt can enter the system. We recommend that you drain the oil from the component if this has not already been done. We recommend an early resample to monitor this condition. Please specify the component make and model with your next sample. Please contact your representative for information regarding the proper sampling kits for your service. NOTE: We recommend using MOB 2 test kits, this testkit includes Particle Count to determine the ISO cleanliness of the fluid.
