OIL ANALYSIS REPORT

Machine Id
EPIROC MT65 TRK 219

Component
Front Differential

Fluid
PENNZOIL SYNTHETIC SAE 75W140 GL-5 (--- GAL)

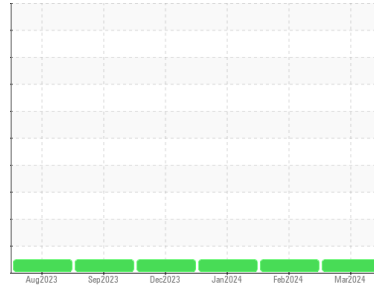
Sample Rating Trend

NORMAL

Resample at the next service interval to monitor.

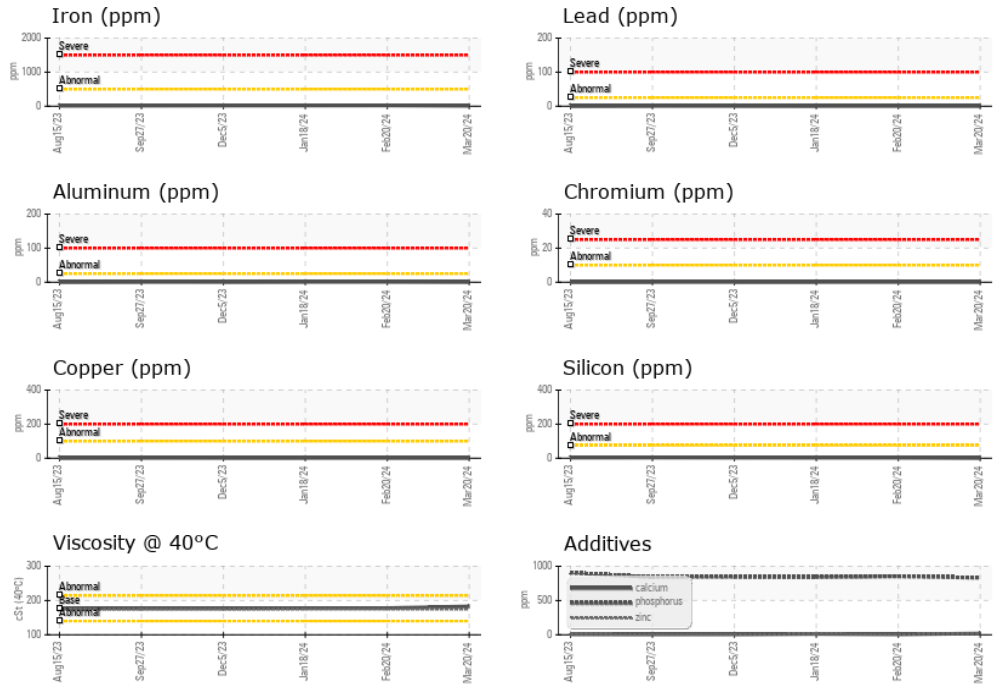
GRAPHS

All component wear rates are normal.

There is no indication of any contamination in the oil.

The condition of the oil is acceptable for the time in service.
