# OIL ANALYSIS REPORT

Area  
**SAB2**  
 Machine Id  
**SAB2 G23**

Component  
**Middle Guide Bearing**  
 Fluid  
**ESSO TERESSO ISO 46 (364 LTR)**

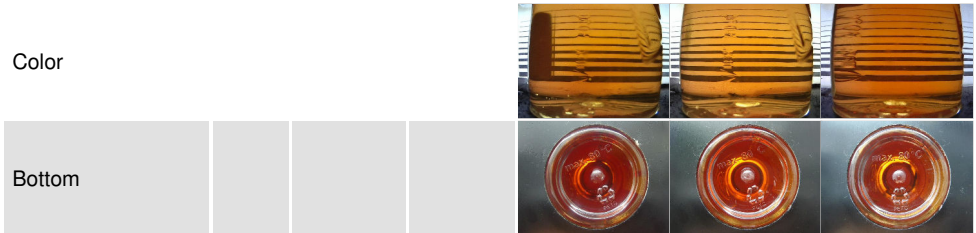
SAMPLE IMAGES	method	limit/base	current	history1	history2
---------------	--------	------------	---------	----------	----------

VISUAL	method	limit/base	current	history1	history2	
White Metal	scalar	Visual*	NONE	<b>NONE</b>	NONE	NONE
Yellow Metal	scalar	Visual*	NONE	<b>NONE</b>	NONE	NONE
Precipitate	scalar	Visual*	NONE	<b>NONE</b>	NONE	NONE
Silt	scalar	Visual*	NONE	<b>NONE</b>	NONE	NONE
Debris	scalar	Visual*	NONE	<b>NONE</b>	NONE	NONE
Sand/Dirt	scalar	Visual*	NONE	<b>NONE</b>	NONE	NONE
Appearance	scalar	Visual*	NORML	<b>NORML</b>	NORML	NORML
Odor	scalar	Visual*	NORML	<b>NORML</b>	NORML	NORML
Emulsified Water	scalar	Visual*	>2	<b>NEG</b>	NEG	NEG
Free Water	scalar	Visual*		<b>NEG</b>	NEG	NEG

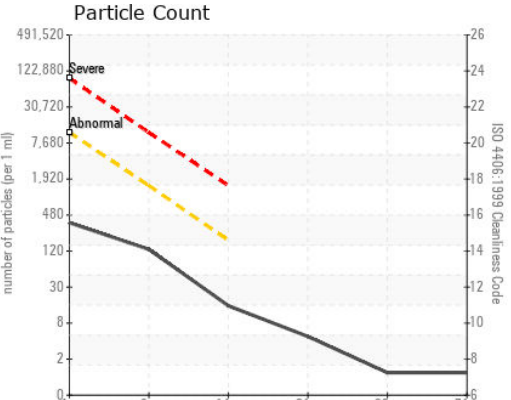
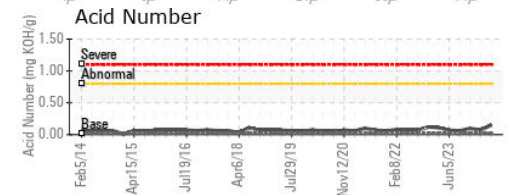
## GRAPHS

All component wear rates are normal.

The system cleanliness is acceptable for your target ISO 4406 cleanliness code. The system and fluid cleanliness is acceptable.

The AN level is acceptable for this fluid. The condition of the oil is suitable for further service.

Resample at the next service interval to monitor.
