# OIL ANALYSIS REPORT

Area  
**SAB2**  
Machine Id  
**SAB2 G18**

Component  
**Thrust Bearing**  
Fluid  
**ESSO TERESSO ISO 46 (5000 LTR)**

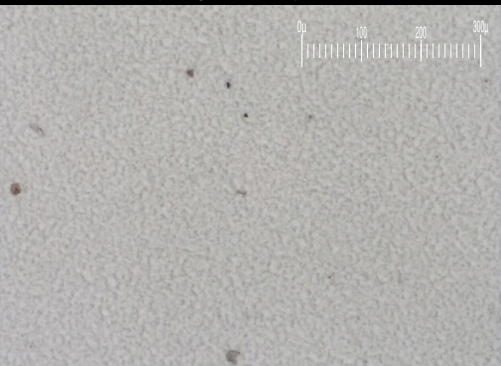
Particle Filter (Magn: 100 x)

The system cleanliness is acceptable for your target ISO 4406 cleanliness code. The system and fluid cleanliness is acceptable.
