OIL ANALYSIS REPORT

Area
SAB2
Machine Id
SAB2 G19
Component
Thrust Bearing
Fluid
ESSO TERESSO ISO 46 (3182 LTR)

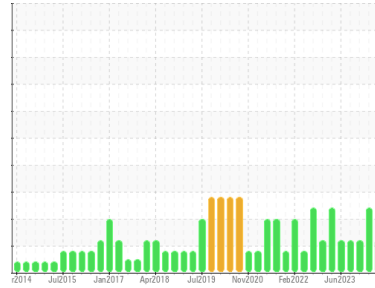
Sample Rating Trend

There is a moderate amount of silt (particulates < 14 microns in size) present in the oil. The system cleanliness is above the acceptable limit for the target ISO 4406 cleanliness code.

method	limit/base	current	history1	history2
Particles >4µm	ASTM D7647	>10000	▲ 51264	▲ 44747	▲ 33994
Particles >6µm	ASTM D7647	>1300	▲ 4868	▲ 3343	● 2452
Particles >14µm	ASTM D7647	>160	22	32	12
Particles >21µm	ASTM D7647	>40	4	7	3
Particles >38µm	ASTM D7647	>10	1	1	0
Particles >71µm	ASTM D7647	>3	1	0	0
Oil Cleanliness	ISO 4406 (c)	>20/17/14	▲ 23/19/12	▲ 23/19/12	▲ 22/18/11

We recommend you service the filters on this component. We recommend an early resample to monitor this condition. Please contact your representative for information regarding the proper sampling kits for your service. NOTE: We recommend using IND 3 test kits, this testkit includes Analytical Ferrography which provides a detailed morphological analysis of wear particles present in the fluid.

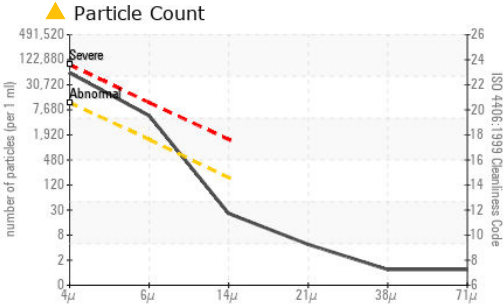
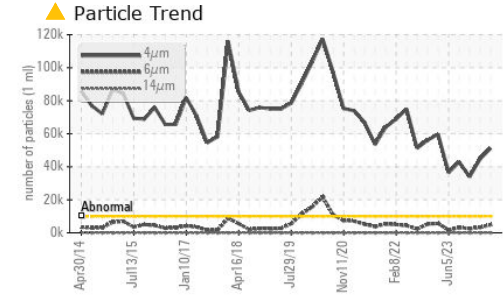
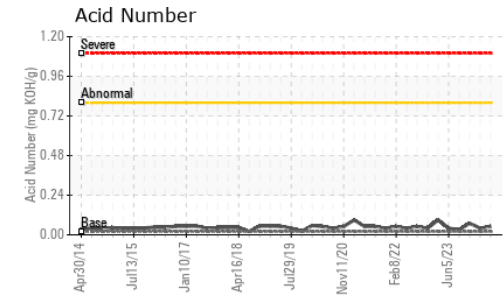
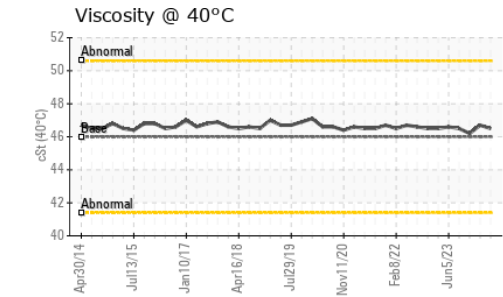
FLUID DEGRADATION		method	limit/base	current	history1	history2
Acid Number (AN)	mg KOH/g	ASTM D974*	0.02	0.05	0.04	0.07

VISUAL		method	limit/base	current	history1	history2
White Metal	scalar	Visual*	NONE	NONE	▲ LIGHT	NONE
Yellow Metal	scalar	Visual*	NONE	NONE	NONE	NONE
Precipitate	scalar	Visual*	NONE	NONE	NONE	NONE
Silt	scalar	Visual*	NONE	NONE	NONE	NONE
Debris	scalar	Visual*	NONE	NONE	NONE	VLITE
Sand/Dirt	scalar	Visual*	NONE	NONE	NONE	NONE
Appearance	scalar	Visual*	NORML	NORML	NORML	NORML
Odor	scalar	Visual*	NORML	NORML	NORML	NORML
Emulsified Water	scalar	Visual*	>2	NEG	NEG	NEG
Free Water	scalar	Visual*		NEG	NEG	NEG
