OIL ANALYSIS REPORT

Area
Materials Handling/NE Pedestal Crane
 Machine Id
WPD471231 CRANE PEDESTAL NORTH EAST

Component
Auxiliary Brake
 Fluid
MOBIL MOBILUBE HD 80W90 (--- GAL)

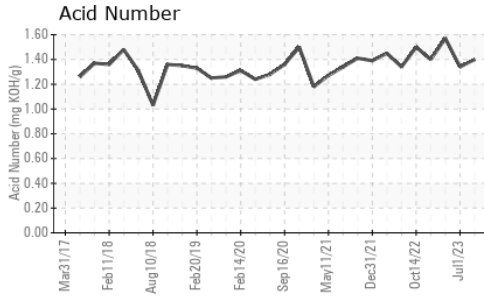
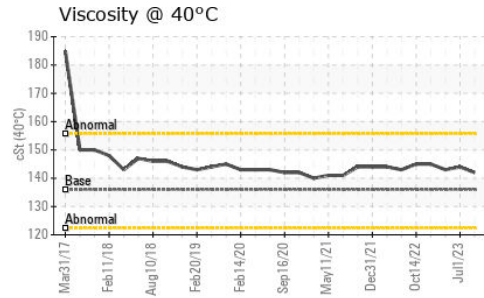
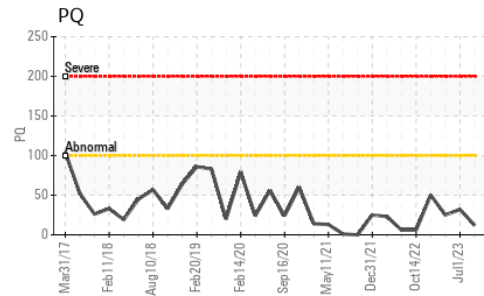
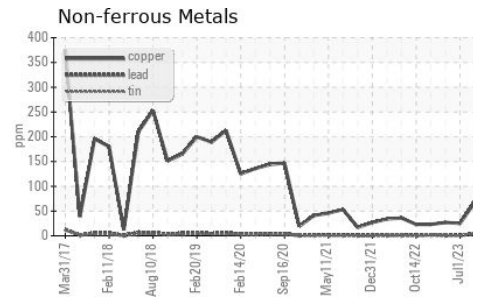
SAMPLE IMAGES	method	limit/base	current	history1	history2
---------------	--------	------------	---------	----------	----------

Color

Bottom

PrtFilter

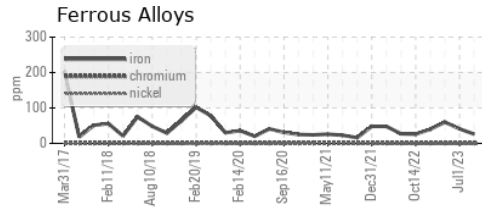
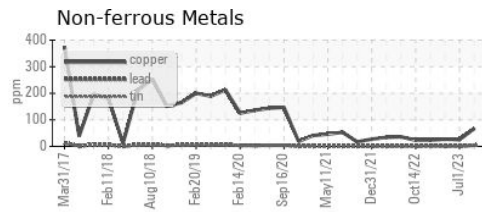
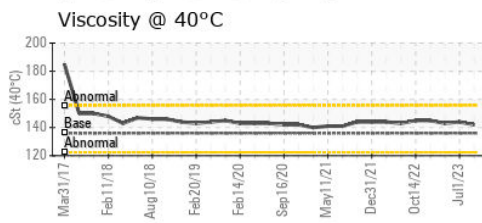
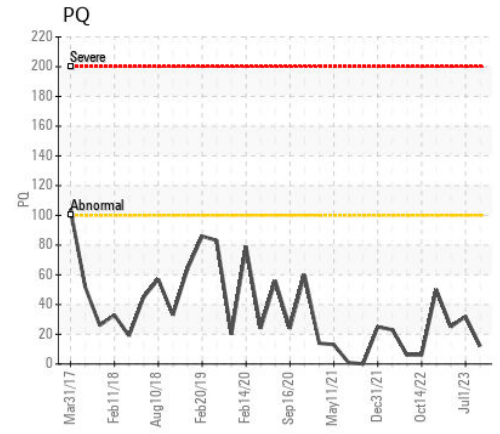
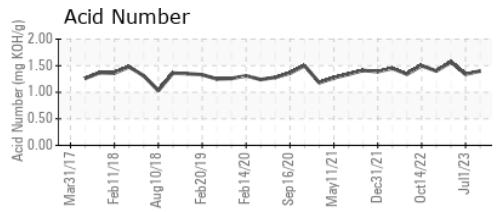
GRAPHS

All component wear rates are normal.

There is no indication of any contamination in the fluid.

The AN level is acceptable for this fluid. The condition of the fluid is suitable for further service.

Resample at the next service interval to monitor.
 NOTE: Please provide information regarding reservoir capacity, filter type and micron rating with next sample. Please specify the component make and model with your next sample.
