# OIL ANALYSIS REPORT

Machine Id  
**LLG1LOS**  
 Component  
**Hydraulic System**  
 Fluid  
**SHELL TELLUS S2 M 46 (900 LTR)**

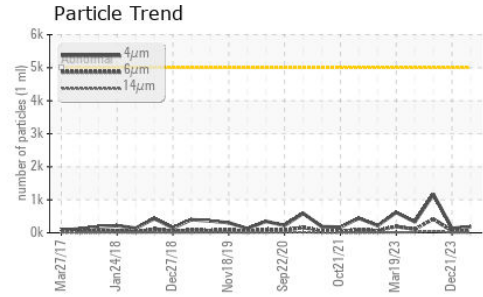
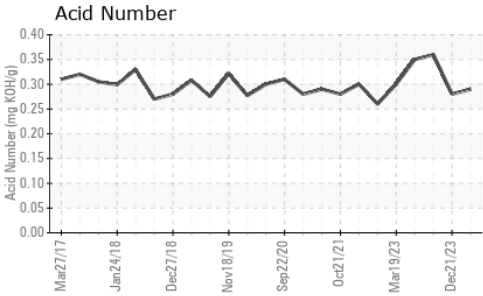
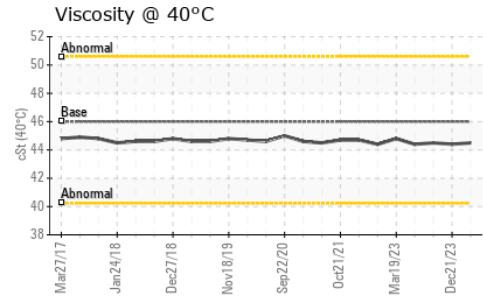
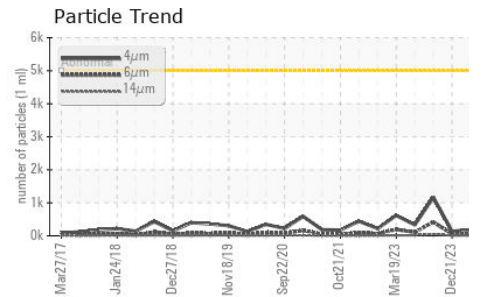
FLUID CLEANLINESS		method	limit/base	current	history1	history2
Particles >4µm		ASTM D7647	>5000	<b>182</b>	139	1163
Particles >6µm		ASTM D7647	>1300	<b>59</b>	54	417
Particles >14µm		ASTM D7647	>160	<b>8</b>	7	44
Particles >21µm		ASTM D7647	>40	<b>3</b>	2	11
Particles >38µm		ASTM D7647	>10	<b>1</b>	0	0
Particles >71µm		ASTM D7647	>3	<b>0</b>	0	0
Oil Cleanliness		ISO 4406 (c)	>19/17/14	<b>15/13/10</b>	14/13/10	17/16/13

FLUID DEGRADATION		method	limit/base	current	history1	history2
Acid Number (AN)	mg KOH/g	ASTM D974*		<b>0.29</b>	0.28	0.36

Resample at the next service interval to monitor.

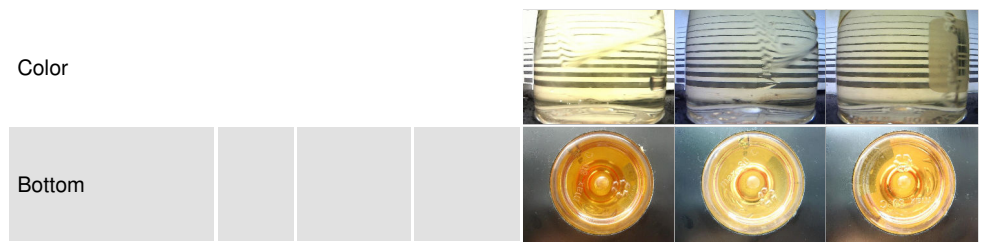
### SAMPLE IMAGES

The system cleanliness is acceptable for your target ISO 4406 cleanliness code. The system and fluid cleanliness is acceptable.

VISUAL		method	limit/base	current	history1	history2
White Metal	scalar	Visual*	NONE	<b>NONE</b>	NONE	NONE
Yellow Metal	scalar	Visual*	NONE	<b>NONE</b>	NONE	NONE
Precipitate	scalar	Visual*	NONE	<b>NONE</b>	NONE	NONE
Silt	scalar	Visual*	NONE	<b>NONE</b>	NONE	NONE
Debris	scalar	Visual*	NONE	<b>NONE</b>	NONE	NONE
Sand/Dirt	scalar	Visual*	NONE	<b>NONE</b>	NONE	NONE
Appearance	scalar	Visual*	NORML	<b>NORML</b>	NORML	NORML
Odor	scalar	Visual*	NORML	<b>NORML</b>	NORML	NORML
Emulsified Water	scalar	Visual*	>0.05	<b>NEG</b>	NEG	NEG
Free Water	scalar	Visual*		<b>NEG</b>	NEG	NEG

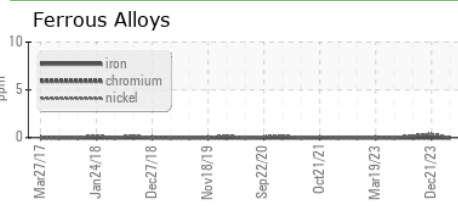
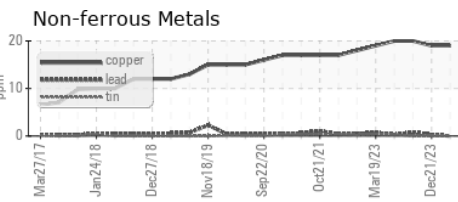
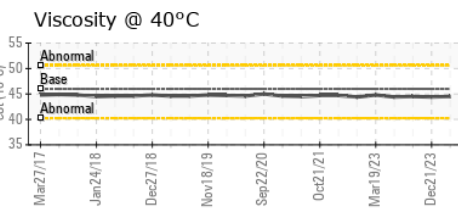
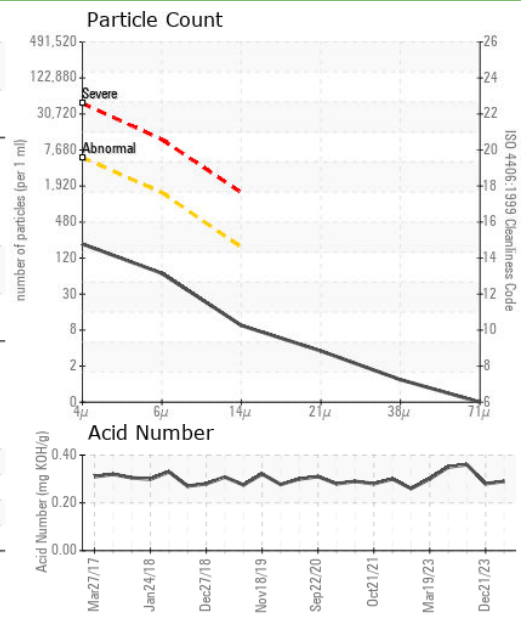
### GRAPHS

All component wear rates are normal.

The AN level is acceptable for this fluid. The condition of the oil is suitable for further service.
