OIL ANALYSIS REPORT

Area
3 Calender Line
 Machine Id
49-0003 Spare Banbury
 Component
Gearbox
 Fluid
SUNOCO SUNEP 320 (30 GAL)

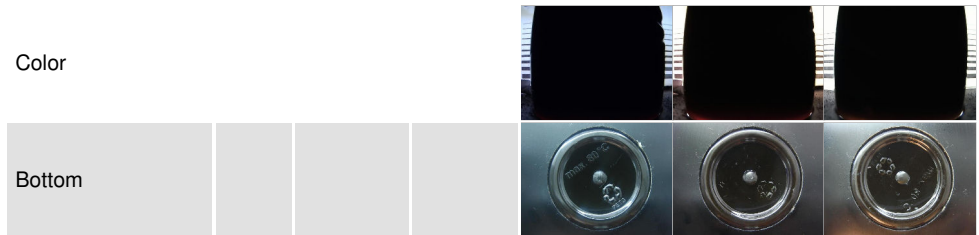
SAMPLE IMAGES	method	limit/base	current	history1	history2
---------------	--------	------------	---------	----------	----------

VISUAL	method	limit/base	current	history1	history2
White Metal	scalar	Visual*	NONE	NONE	NONE
Yellow Metal	scalar	Visual*	NONE	NONE	NONE
Precipitate	scalar	Visual*	NONE	NONE	NONE
Silt	scalar	Visual*	NONE	NONE	NONE
Debris	scalar	Visual*	NONE	NONE	NONE
Sand/Dirt	scalar	Visual*	NONE	NONE	NONE
Appearance	scalar	Visual*	NORML	NORML	NORML
Odor	scalar	Visual*	NORML	NORML	NORML
Emulsified Water	scalar	Visual*	>0.2	NEG	NEG
Free Water	scalar	Visual*		NEG	NEG

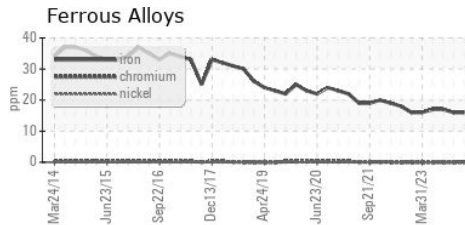
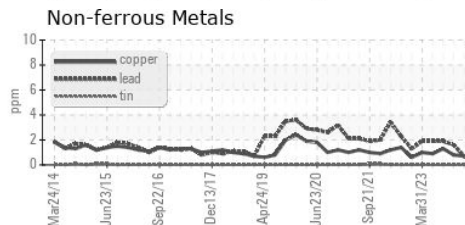
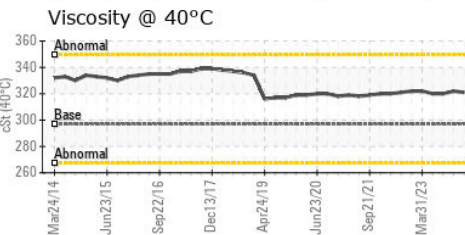
GRAPHS

All component wear rates are normal.

There is no indication of any contamination in the oil.

The condition of the oil is acceptable for the time in service.

Resample at the next service interval to monitor.
